## San Vincente Redwoods: Redwood Defect Pilot Study

## Tree #388

## Tree #322

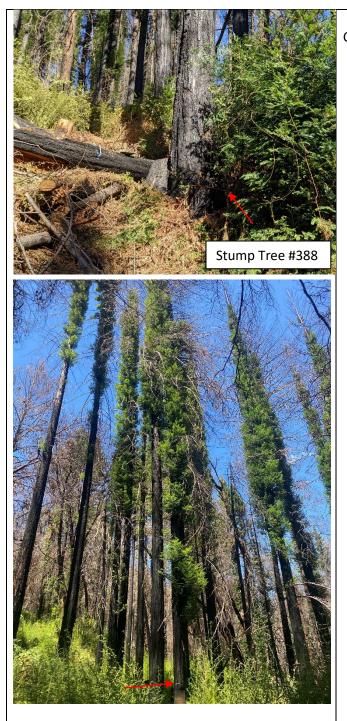
- 1<sup>st</sup> log 18" Inside Bark (IB) 270 bf (board feet) gross volume
- Deduct 120 bf for damage from 2020 fire 44% deduction (between red arrows)
- 150 bf net volume
- Deductions:
- 3" of rot from 2020 fire around 2/3 of circumference = 120 bf deduction
- Past Damage: 42 years ago (1980) (yellow arrow) - possible mechanical damage = 5 bf deduction
- 2<sup>nd</sup> log 13" IB 120 bf net
- No deductions from 2020 fire
- "Stain" visible in heartwood
- 3<sup>rd</sup> log 8" IB 30 bf net
- No defect from 2020 fire
- Top of the tree is very dry

2020 merchantable volume for tree: 420 bf gross 120 bf deduction from damage due to 2020 fire 300 bf net ~29% defect due to 2020 fire

At a 2% growth rate, (projected growth rate postfire as leaf area regrows) this tree is anticipated to put on 3" of diameter growth (1.5" per side) over the next 10 years. The 1<sup>st</sup> 20' log represents 64% of the volume from the tree. Since 2/3 of the circumference of the 1<sup>st</sup> log is impacted by rot in heat-damaged wood, the future growth is expected to take approximately ? years to encapsulate this rot. It is possible that the rot in trees with this degree of damaage will extend inward and upward from what is observed in 2022, two years post-fire.

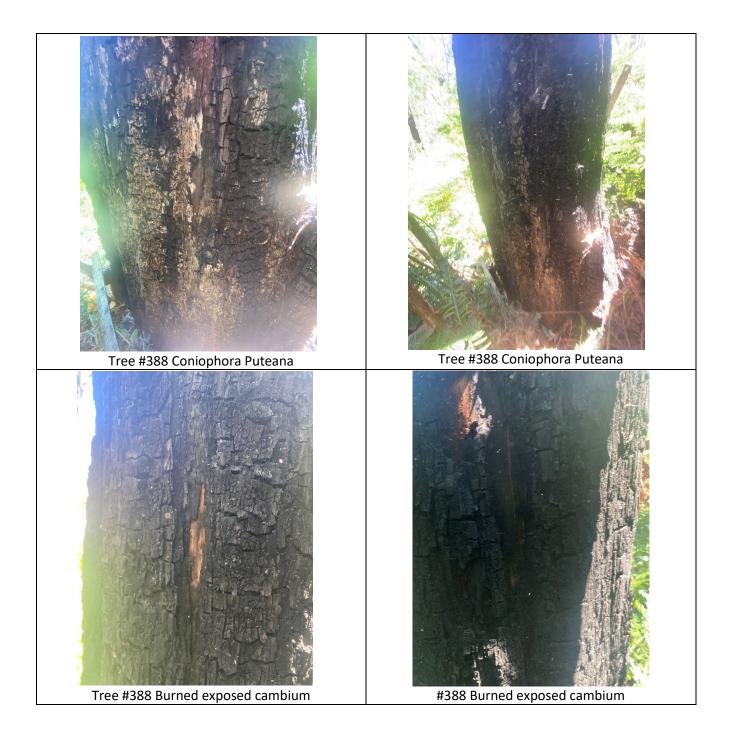
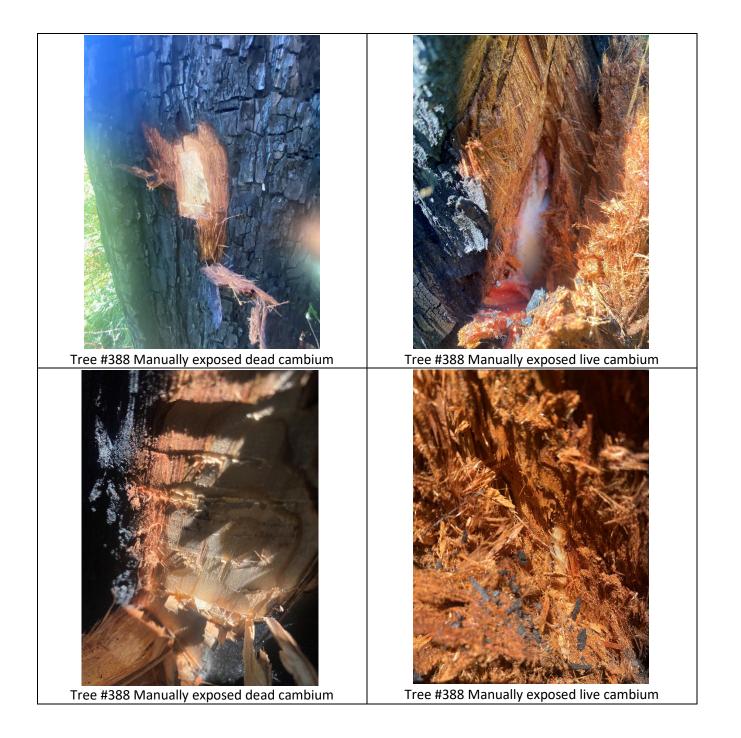
Condition of tree in 2022:

- DBH: 20
- Height: 83', with a broken top
- Burn Severity: Moderate-high
- Crown: 95% torched, 5% scorched; 0% live pre-fire canopy
- Fungus visible: 2/4 quadrants
- Dead cambium: 2/4 quadrants
- Scorch height: 72'
- Torch height: 83'
- Max bole char height: 83'
- Sprouting from: Bole
- Sprouting % of tree: 70
- Feet<sup>2</sup> of sprouts at base: 5
- Mold area: 8\*11" and 11\*40" patches on bole, 464 inches<sup>2</sup>
- Cambium completely burned away in some patches

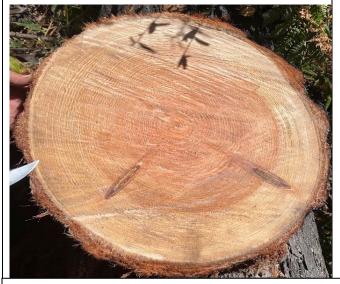
1<sup>st</sup> Log small end – No 2020 Damage, yellowing sapwood

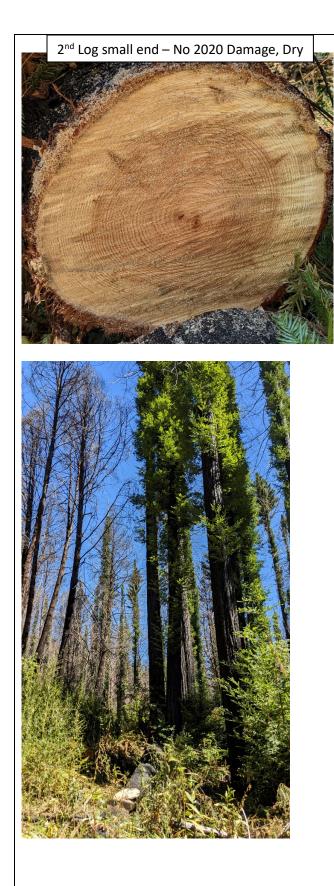
- 1<sup>st</sup> log 13" IB = 120 bf gross volume
- No deductions from 2020 fire
- Yellowing sapwood, 80% dry
- Deductions:
- No deductions from 2020 fire\*
- Past Damage: 32 years ago (1990) and 49 years ago (1973) (yellow arrows) - possible mechanical damage – not visible on small end = 10 bf deduction
- 2<sup>nd</sup> log 12" IB 100 bf net
- No deductions from 2020 fire
- Soft, but sound and sapwood is yellowing/dry
- 3<sup>rd</sup> log 8" IB 30 bf net
- No defect from 2020 fire
- Top of the tree is very dry

2020 merchantable volume for tree: 250 bf net

\*0% duduction due to 2020 fire damage; however damage to the cambium and very thin layer of sapwood over 1/3 of circumference on large end (red arrows) would impact future defect as the tree continues to grow and encapsulate the rot pockets.

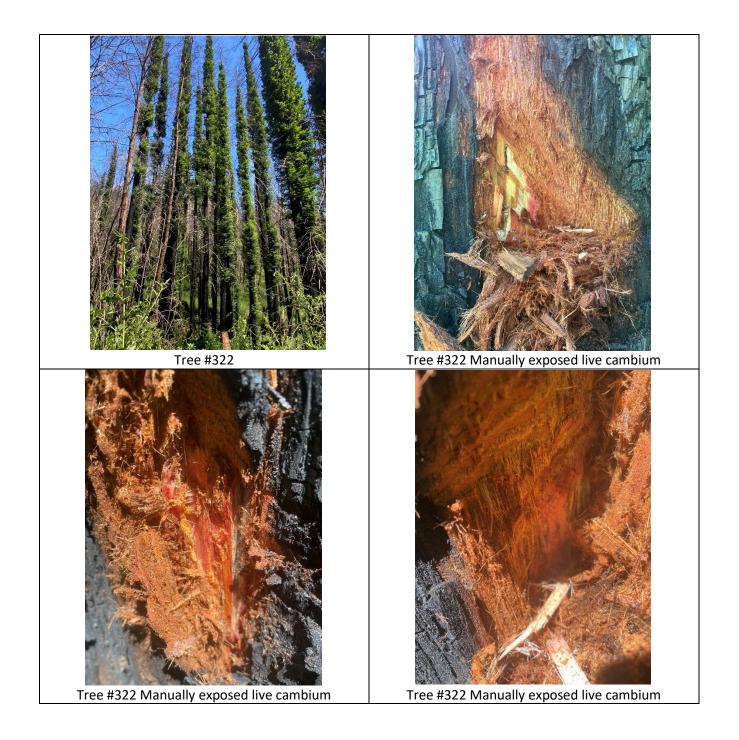
Condition of tree in 2022:

- In riparian corridor
- DBH: 22
- Height: 139'
- Burn Severity: High
- Crown: 100% torched, 0% scorched; 0% live pre-fire canopy
- Fungus visible: 1/4 quadrants
- Dead cambium: 1/4 quadrants
- Scorch height: 0'
- Torch height: 139'
- Max bole char height: 139'
- Sprouting from: Bole
- Sprouting % of tree: 75
- Feet<sup>2</sup> of sprouts at base: 7
- Fungus area: 114 inches<sup>2</sup>
