Santa Cruz Mountains Post-Fire Redwood Defect Study

Nadia Hamey, Hamey Woods

CZU Lightning Complex Fire

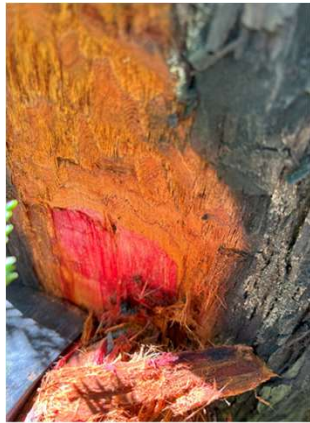
West
Alive,
Fungus

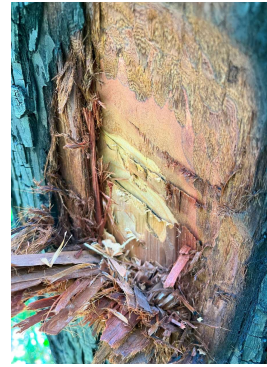
North
Dead,
Fungus

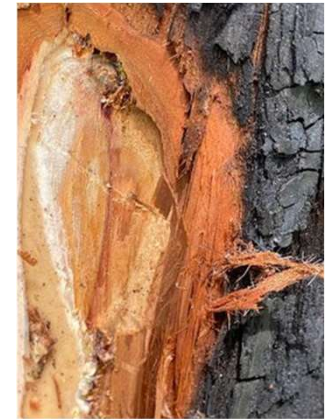
East
Dead,
No fungus

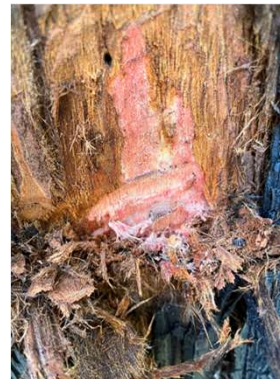
South
Alive,
No fungus

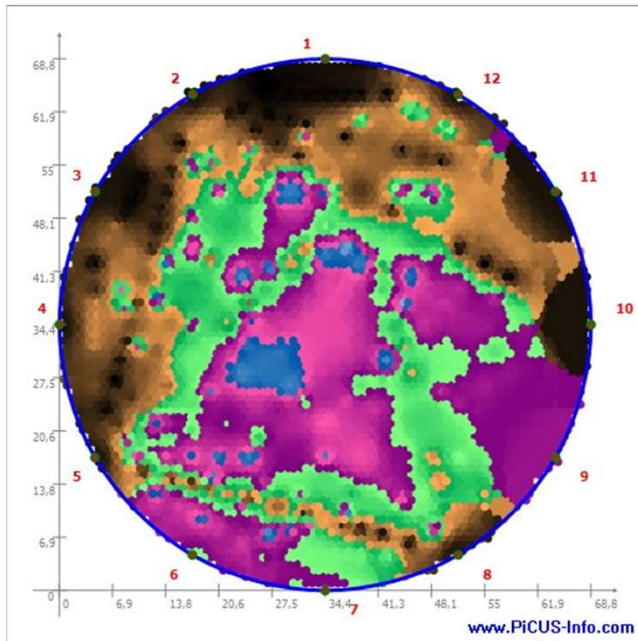
Sonic Tomography

62% Decay

35% Severe Decay

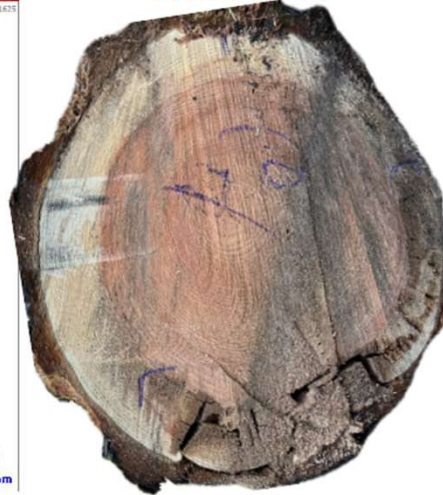
Log #1- Big End:

I = North [] = Sapwood rot

- 17" Inside Bark (IB) before deductions
- 1-2" of sapwood rot around 45% circumference to the edge of heartwood
- Yellowing sapwood

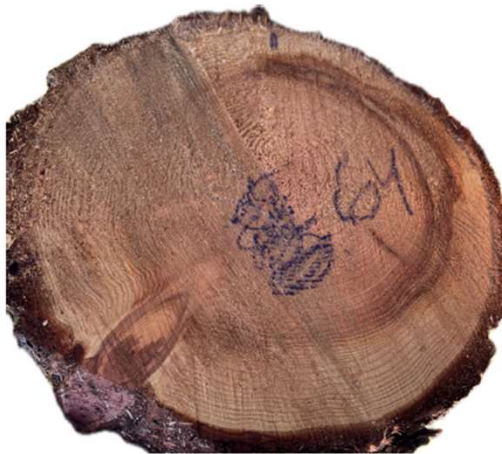
Log #1 Small End/ Log #2 Big End

- 11" IB
- Healthy sapwood and heartwood

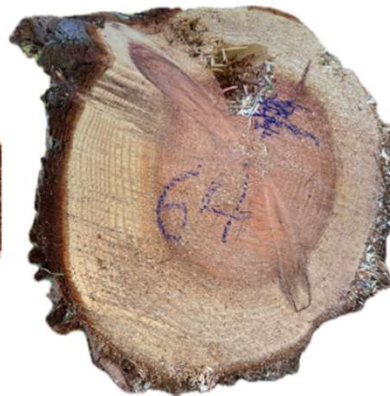
Log #2 Small End

- 9" IB
- Healthy sapwood and heartwood
- Slight mechanical damage

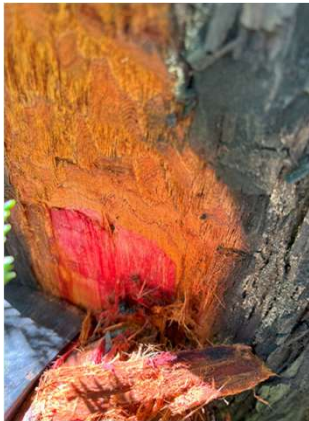
West
Alive,
Fungus
