EMERGENCY NOTICE OF TIMBER OPERATIONS MONITORING AND REPORT ON EXEMPTION USAGE

December 2, 2019

Will Olsen, Drew Coe, Stacy Stanish, and Pete Cafferata

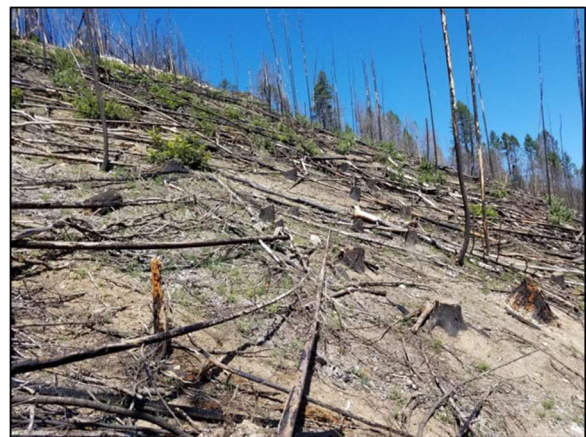
Figure 4: An example of a harvest that was closest in silviculture to a clearcut.

While a portion of the Emergencies had complete removal of merchantable timber, harvesting trends within most Emergency boundaries were typically less intensive spatially, following post-fire/post-insect tree mortality patterns and the presence of merchantable commercial timber. Forty-three percent of the Emergencies were closest to single tree selection (i.e., dispersed tree removal) for a silvicultural treatment, 36% were closest to a clearcut (i.e., complete

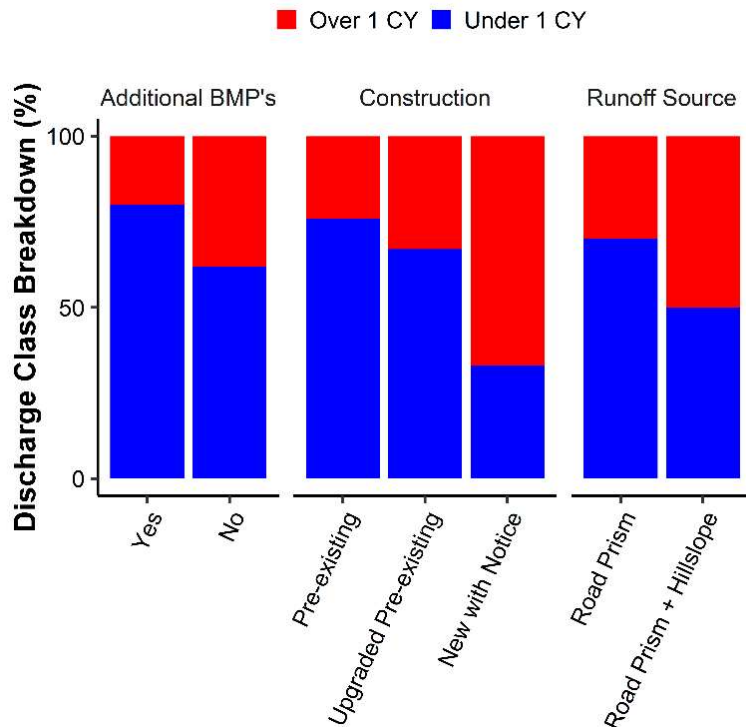
Figure 5: Watercourse crossing discharges, as under 1 yard³ and greater than or equal to 1 yard³, by the presence of extra BMPs, crossing construction, and the runoff and runoff source at crossings.

Extra effort to reduce runoff and discharge at crossings resulted in decreased detrimental discharges, while a majority of newly built crossings had detrimental sediment discharges. When additional Best Management Practices (BMPs) such as rock armoring of outlets were observed, 80% of the discharges on crossings were less than 1 yard³, while without additional BMPs only 62% of discharges were less than 1 yard³ (Figure 5). Newly constructed crossings had a higher percentage of discharges over 1 yard³, compared to pre-existing and upgraded pre-existing crossings (Figure 5). When both the hillslope and road prism (i.e., road runoff combined with runoff from burned hillslopes) contributed runoff to a crossing, 50% of discharges were over 1 yard³, compared to 30% of discharges being over 1 yard³ when it was only from the road prism.

The physical construction of some crossings, and materials used, may explain many of the “Substandard” and “Unacceptable” performances, in addition to crossings not including certain BMPs or being subject to winter operations. Eight watercourse crossings, or 17% of the crossings, had the potential for watercourse diversion (i.e., watercourses being routed down roads with

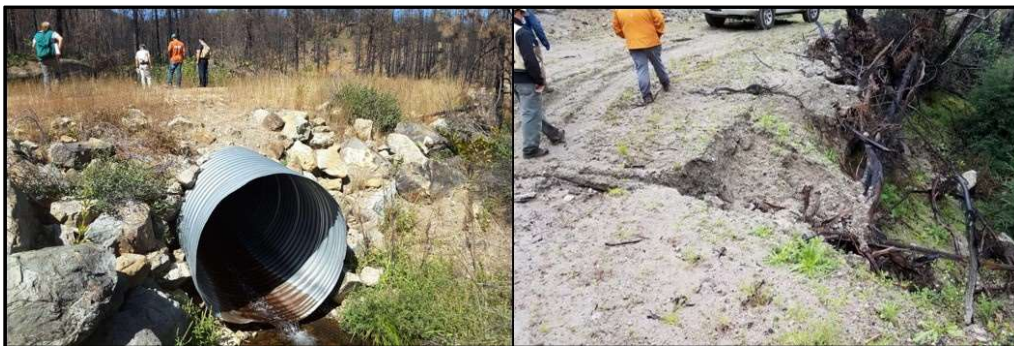
Figure 6: Two crossings, a culvert crossing of a Class II watercourse with a “Trace” discharge (left) and extra rock added on the outboard edge, and a dry ford crossing on a Class III with an eroding road prism (partially shown) and failing outboard edge, with a 5-10 yard³ discharge estimate.

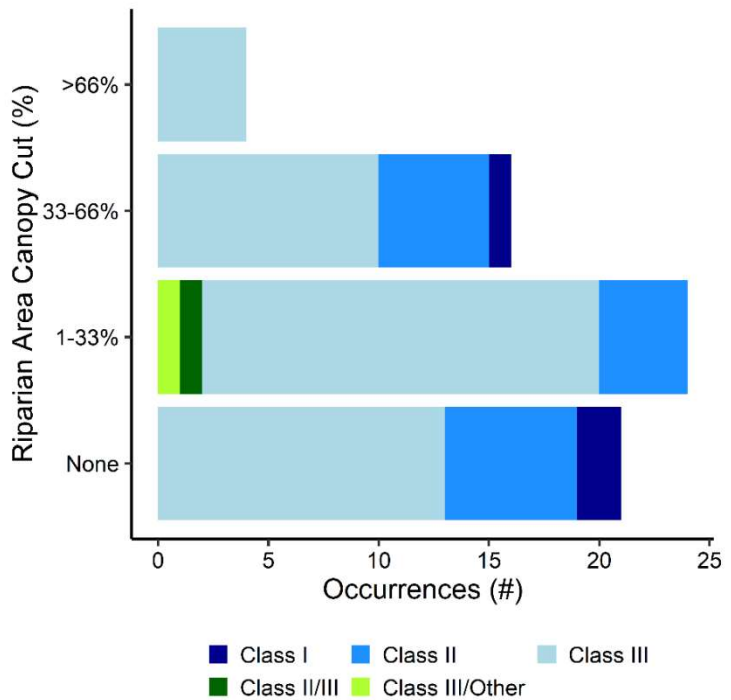
Figure 7: Binned percent canopy cut in riparian protection areas. Fill colors correspond to the watercourse classification on the assessed segment.

Generally, harvesting in riparian buffer areas was less intensive (i.e., light touch) or absent, and equipment disturbance limited to Class III watercourses. Seven watercourses (11%) had equipment crossings occurring on seven Emergencies (15% of the harvested Notices). All crossings occurred on Class III watercourses. There were no observed encroachments into WLPZs by equipment on any of the Class II or Class I watercourses. Thirty percent (30%) of the Emergencies that had a Class III watercourse present had encroachments on a Class III, for a total of 11 encroachments on Class III’s. Harvesting of the canopy in protection zones was generally non-existent to relatively low; 68% of the watercourses were in the “None” and “1-33%” canopy cut categories (Figure 7). Twenty-five percent had more intensive 33-66% cut, and 6% were more than 2/3rd or 66% cut (Figure 7). The latter category was exclusively on Class III watercourses.

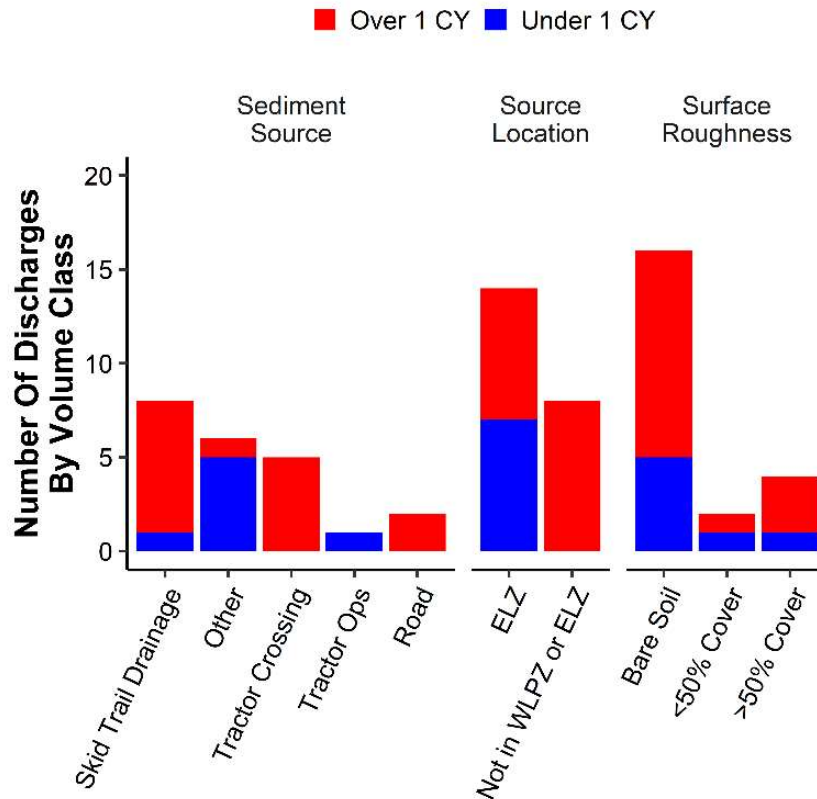
Figure 8: Discharges to watercourses under 1 yard³ and greater than or equal to 1 yard³, by the sediment source, source location, and downslope surface roughness below the sediment source.

Of these occurrences, 75% were from skid trails that did not enter a WLPZ or ELZ area (i.e., not associated with tractor crossings). Skid crossings of Class III watercourses accounted for 23% of the discharges, all of which were 1 yard³ or greater. “Other” discharges were related in part to burn piles in close proximity to watercourses, and mechanical drag disturbances from long line and cable yarding. These were cases where the lack of ground cover and surface roughness due to fire effects created conditions more prone to sediment delivery from disturbances, with most discharges under 1 yard³ (Figure 8). Discharges with sources in the ELZ were evenly split between discharges under 1 yard³ and those 1 yard³ and more, while all discharges sourced from outside a WLPZ or ELZ were 1 yard³ or more (Figure 8). When downslope flowpaths were bare soil, most sediment discharges exceeded 1 yard³ (Figure 8). Fifteen discharges occurred on Notices with a “Moderate” Erosion Risk Rating, 53% of which were 1 yard³ or more, and seven discharges occurred on notices with a “High” ERR, all of which were 1 yard³ or greater.

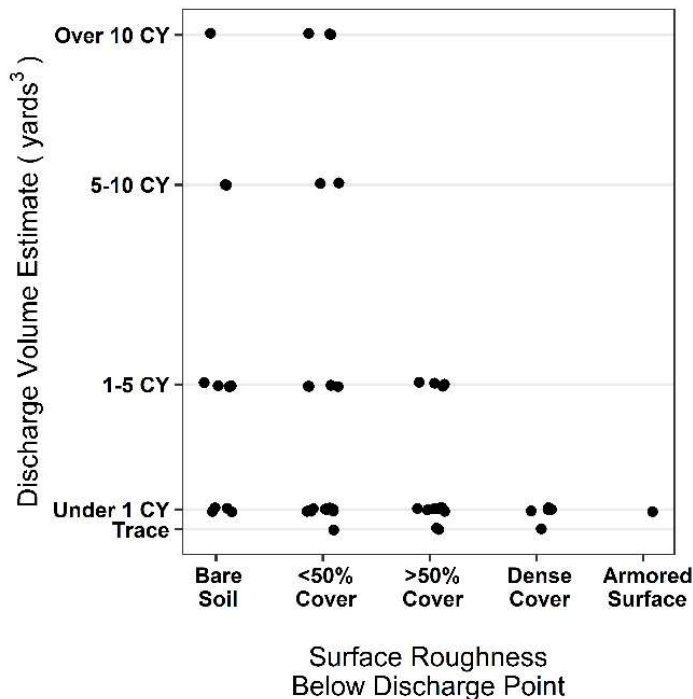
Figure 9: Discharges from haul roads to watercourses and the downslope roughness category (simplified category names shown). Decreasing sediment volume estimates followed increasing surface roughness.

(additional crossings encountered besides the one used for a crossing assessment), followed by rolling dips and waterbars, with 38% and 12% of the discharges, respectively. Outsloped roads accounted for 8% of the discharge points on road segments, followed by 2% for ditch relief features. Fifteen percent (15%) of the road discharge points occurred at road failures (n = 7), which were observed on two Notices. Six of the seven road failures exceeded 1 yard³. Observed discharge volumes from haul roads decreased as the surface roughness downslope of a discharge point increased, particularly where bare soil was minimal (Figure 9).

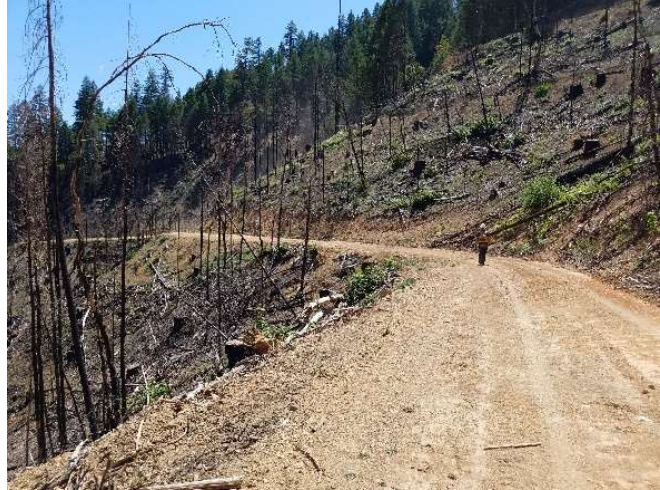
Figure 10: A midslope road on a post-fire Emergency with a road slope of < 5%.

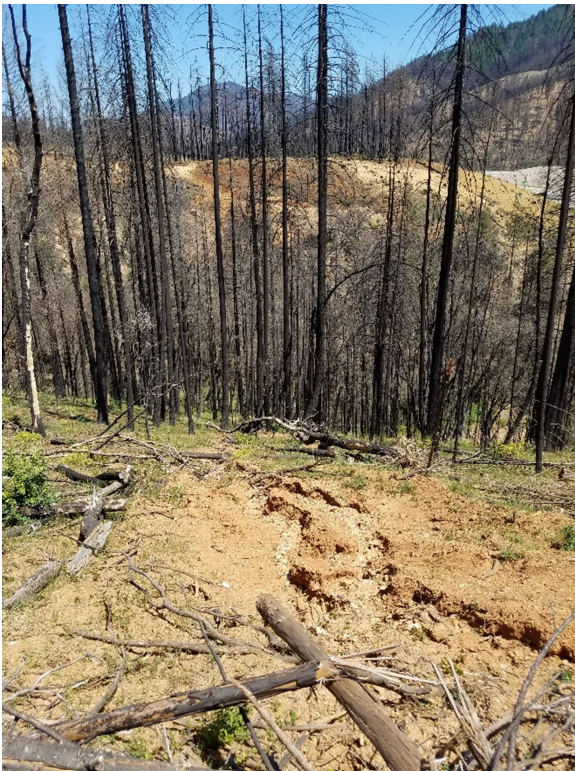
Figure 11: Gully erosion below a skid trail waterbar, cause in part by accumulated upslope drainage, which discharged to a watercourse.

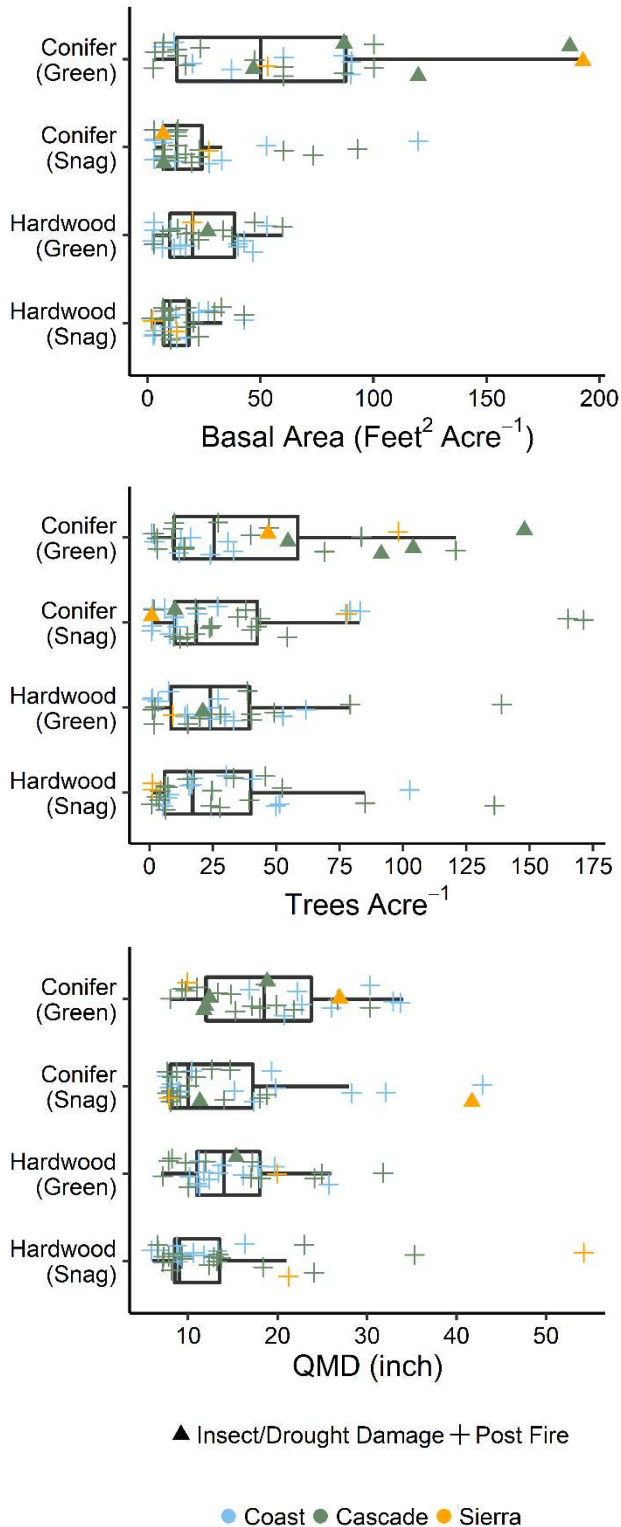
Figure 13: Basal area, trees per acre, and quadratic mean diameter (QMD) by tree type and condition. Shape indicates Notice type, and color indicates Forest Practice Area.

Where each tree type and condition was present, the basal area of green conifers averaged 43 feet² acre⁻¹ on post-fire Notices, and 127 feet² acre⁻¹ on Notices for insect/drought damage and mortality. For conifer snags, post-fire and insect/drought Notices averaged 24 and 7 feet² acre⁻¹, respectively (Figure 13, Table 8).

Conifer snags were largely absent from Notices related to insect or drought mortality, while green conifers were in greater abundance on those Emergencies than post-fire Emergencies (Figure 13, Table 8). Hardwood snags had the lowest basal area, density, and QMD on Emergencies, and were exclusively found on the post-fire Emergencies. Relative comparisons to the Drought Mortality Exemptions monitored in 2018 can be
