## EMERGENCY NOTICE OF TIMBER OPERATIONS MONITORING AND REPORT ON EXEMPTION USAGE

December 2, 2019

Will Olsen, Drew Coe, Stacy Stanish, and Pete Cafferata

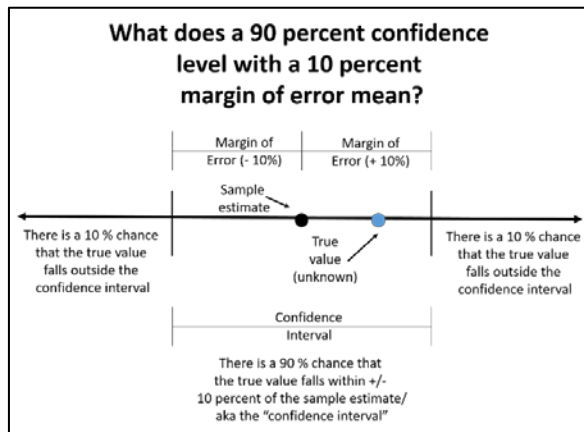
Figure 1: Visual representation of the confidence level and margin of error used in the study design.

FIRE. Sampling approximately 20% of the Notice population results in a 90% confidence level and 10% margin of error (Figure 1). Emergencies that did not overwinter or have significant precipitation events following operations, had a timberland owner who did not wish to be involved in monitoring, or were deemed unsafe for field inspection, were removed and a random replacement chosen from the remaining 2018 Emergencies. Altogether, 14 of the original Notices were replaced, with 9 being replaced due to not meeting the precipitation criteria, and the remaining 5 being replaced due to a combination of safety, timberland owner unwillingness to participate, and the inability to establish contact with timberland owners. A sampled Emergency did not need to have a Completion Report filed, only operations completed in the monitored area and the overwintering/significant precipitation requirement (i.e., multiple storms of sufficient intensity to generate runoff in a burned environment; >0.2 inch per hour). If an

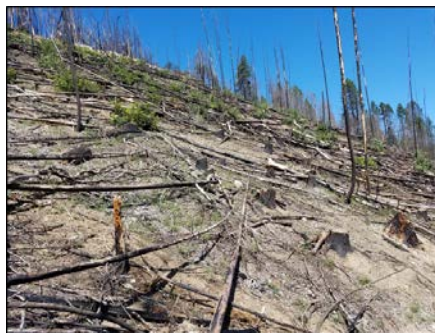
**Figure 4:** An example of a harvest that was closest in silviculture to a clearcut.

**While a portion of the Emergencies had complete removal of merchantable timber, harvesting trends within most Emergency boundaries were typically less intensive spatially, following post-fire/post-insect tree mortality patterns and the presence of merchantable commercial timber.** Forty-three percent of the Emergencies were closest to single tree selection (i.e., dispersed

tree removal) for a silvicultural treatment, 36% were closest to a clearcut (i.e., complete or almost complete tree removal), and 21% were approximate to group selection (i.e., small to medium groups of trees removed). ~~Habitat retention areas were observed on several Emergencies that were similar to clearcuts.~~ The total proportion of the Notice area harvested ranged from minimal across an entire Emergency boundary, with 19% of the harvested Notices having only 0-25% of the total area harvested, to 23% experiencing 75-100% harvest. Twenty-six (26%) and 32% of the Emergencies fell in the 25-50% and 50-75% area harvested categories, respectively.

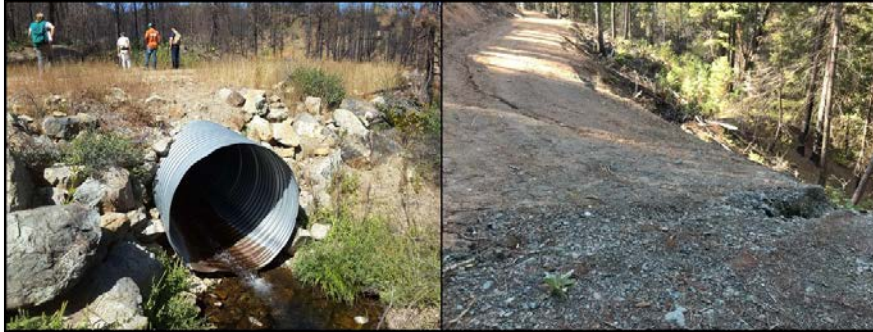
**Figure 6:** Two crossings, a culvert crossing of a Class II watercourse with a “Trace” discharge (left) and extra rock added on the outboard edge, and a dry ford crossing on a Class III with rill erosion on the eroding road prism (partially shown) and failing outboard edge, with a 15-540 yard<sup>3</sup> discharge estimate.

**certain BMPs or being subject to winter operations.** Eight watercourse crossings, or 17% of the crossings, had the potential for watercourse diversion (i.e., watercourses being routed down roads with the potential for severe erosion), and these occurrences were associated with seven Emergencies. There was no clear trend relating sediment discharge estimates to crossing approach length and hydrologic connectivity; this may be due in part to the occurrence of crossings on paved residential roads that doubled as haul roads (n = 4), adequacy of the crossing construction itself, and the occurrence of flat roads that showed no/little evidence of erosion.

Observationally, visual signs of hauling activity in wet or saturated conditions, such as significant rutting on road surfaces with insufficient rock or native material surfaces on or near some crossings, created performance issues that often led to sediment discharges.

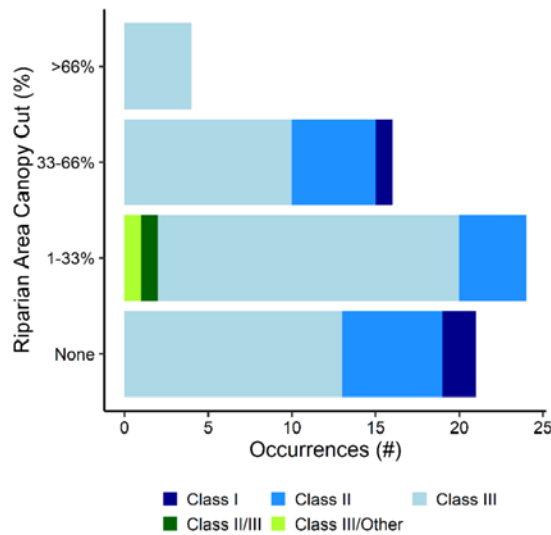
**Figure 7:** Binned percent canopy cut in riparian protection areas. Fill colors correspond to the watercourse classification on the assessed segment.

**Generally, harvesting in riparian buffer areas was less intensive (i.e., light touch) or absent, and equipment disturbance limited to Class III watercourses.** Seven watercourses (11%) had equipment crossings occurring on seven Emergencies (15% of the harvested Notices). All crossings occurred on Class III watercourses. There were no observed encroachments into WLPZs by equipment on any of the Class II or Class I watercourses. Thirty percent (30%) of the Emergencies that had a Class III watercourse

present had encroachments on a Class III, for a total of 11 encroachments on Class III's. Harvesting of the canopy in protection zones was generally non-existent to relatively low; 68% of the watercourses were in the "None" and "1-33%" canopy cut categories (Figure 7). Twenty-five percent had more intensive 33-66% cut, and 6% were more than 2/3<sup>rd</sup> or 66% cut (Figure 7). The latter category was exclusively on Class III watercourses.

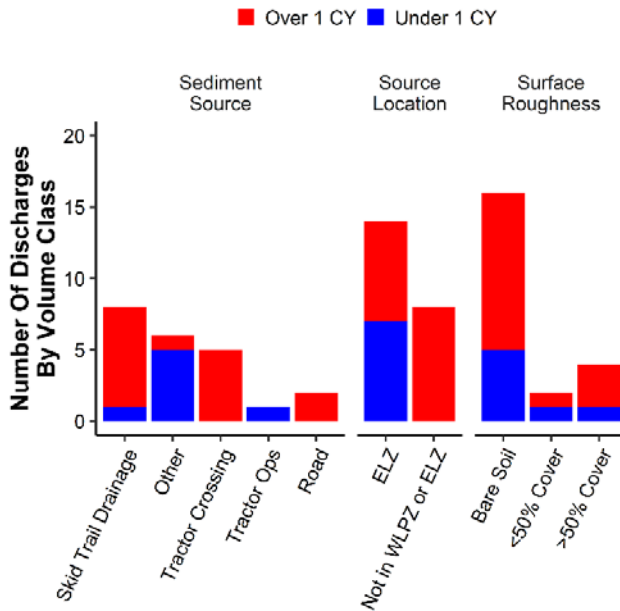
**Figure 8:** Discharges to watercourses under 1 yard<sup>3</sup> and greater than or equal to 1 yard<sup>3</sup>, by the sediment source, source location, and downslope surface roughness below the sediment source.

Of these occurrences, 75% were from skid trails that did not enter a WLPZ or ELZ area (i.e., not associated with tractor crossings). Skid crossings of Class III watercourses accounted for 23% of the discharges, all of which were 1 yard<sup>3</sup> or greater. "Other" discharges were related in part to burn piles in close proximity to watercourses, and

mechanical drag-yarding disturbances from long line and cable yarding. These were cases where the lack of ground cover and surface roughness due to fire effects created conditions more prone to sediment delivery from disturbances, with most discharges under 1 yard<sup>3</sup> (Figure 8). Discharges with sources in the ELZ were evenly split between discharges under 1 yard<sup>3</sup> and those 1 yard<sup>3</sup> and more, while all discharges sourced from outside a WLPZ or ELZ were 1 yard<sup>3</sup> or more (Figure 8). When downslope flowpaths were bare soil, most sediment discharges exceeded 1 yard<sup>3</sup> (Figure 8). Fifteen discharges occurred on Notices with a “Moderate” Erosion Risk Rating, 53% of which were 1 yard<sup>3</sup> or more, and seven discharges occurred on notices with a “High” ERR, all of which were 1 yard<sup>3</sup> or greater.

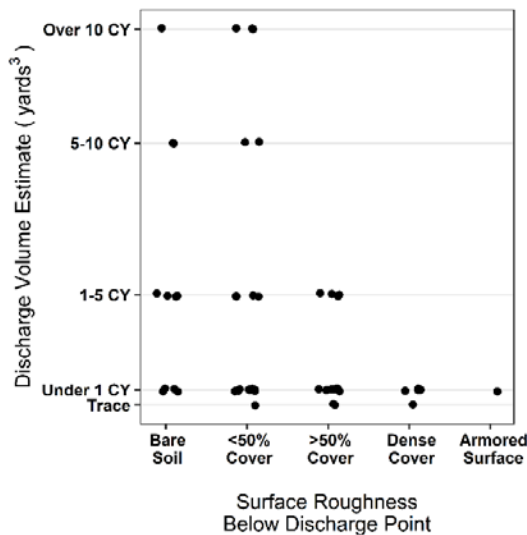
**Figure 9:** Discharges from haul roads to watercourses and the downslope roughness category (simplified category names shown). Decreasing sediment volume estimates followed increasing surface roughness.

followed by rolling dips and waterbars, with 38% and 12% of the discharges, respectively. Outsloped roads accounted for 8% of the discharge points on road segments, followed by 2% for ditch relief features. Fifteen percent (15%) of the road discharge points occurred at road failures (n = 7), which were observed on two Notices. Six of the seven road failures exceeded 1 yard<sup>3</sup>. Observed discharge volumes from haul roads decreased as the surface roughness downslope of a discharge point increased, particularly where bare soil was minimal (Figure 9).

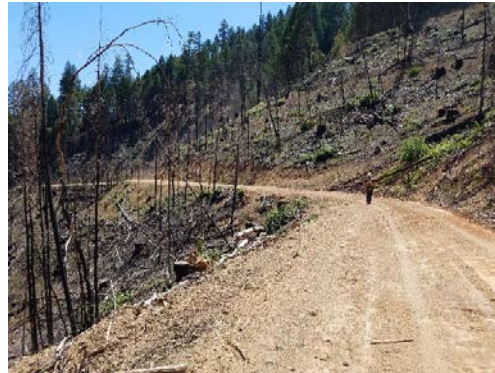
**Figure 10:** A midslope road on a post-fire Emergency with a road slope of < 5%.

**Emergencies generally had native surface roads with gentle-to-moderate slope, on hillslopes less than 40% in gradient, with over 1/3<sup>rd</sup> of the sampled roads discharging to a classified watercourse.** A total of 70 non-public road segments were assessed on 44 of the 47 harvested Emergencies, of which 90% (n = 63) were used for hauling and timber harvest activity on 39 (83%) of the logged Emergencies. An expanded description of the 63 haul roads sampled is presented in Table 5. Discharges from haul roads to watercourses were observed on 37% (23/63) of the roads. Sixty-two percent (62%) of these roads were assessed for the full 1,320 feet segment length, and the remaining 38% were surveyed for an average of 830 feet. The majority of haul roads were native surfaced, pre-existing roads (Figure 10), with almost ¼ of the roads also serving as residential access roads.

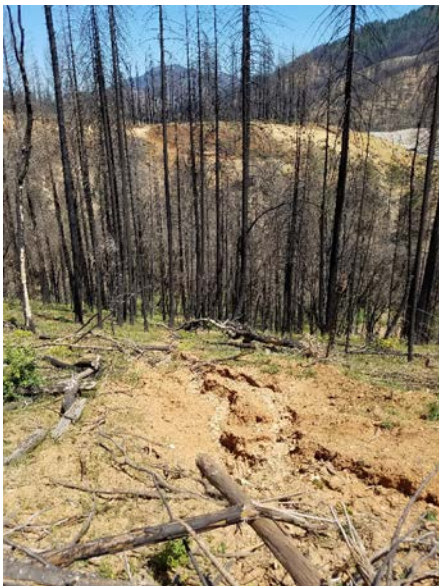
**Figure 11:** Gully erosion below a skid trail waterbar, cause in part by accumulated upslope drainage, which discharged to a watercourse.

- 18% of skid trails had some level of sediment discharge to a watercourse, approximately half due to temporary watercourse crossings, and half due to drainage from skid trails
- Altogether, 10 Notices (21%) had an instance of sediment delivery from a skid trail
- Generally, sediment breakthroughs from skid trails into a riparian buffer zone also resulted in sediment discharge
- Of 72 surveyed skid trails, 24% did not have waterbreaks within the surveyed length of the skid trail

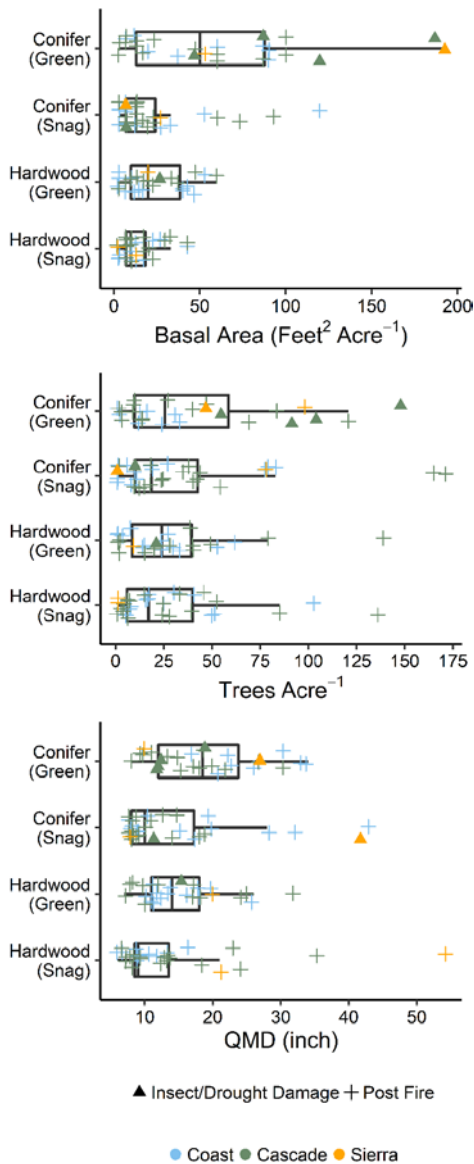
**Figure 13:** Basal area, trees per acre, and quadratic mean diameter (QMD) by tree type and condition. Shape indicates Notice type, and color indicates Forest Practice Area.

Where each tree type and condition was present, the basal area of green conifers averaged 43 feet<sup>2</sup> acre<sup>-1</sup> on post-fire Notices, and 127 feet<sup>2</sup> acre<sup>-1</sup> on Notices for insect/drought damage and mortality. For conifer snags, post-fire and insect/drought Notices averaged 24 and 7 feet<sup>2</sup> acre<sup>-1</sup>, respectively (Figure 13, Table 8).

than post-fire Emergencies (Figure 13, Table 8). Hardwood snags had the lowest basal area, density, and QMD on Emergencies, and were exclusively found on the post-fire Emergencies. Relative comparisons to the Drought Mortality Exemptions monitored in 2018 can be found in Table 8. In general, conifer snags were more abundant and denser on the sampled post-fire Emergencies in this report than on the Drought Mortality Exemptions reported in Olsen and others (2019).

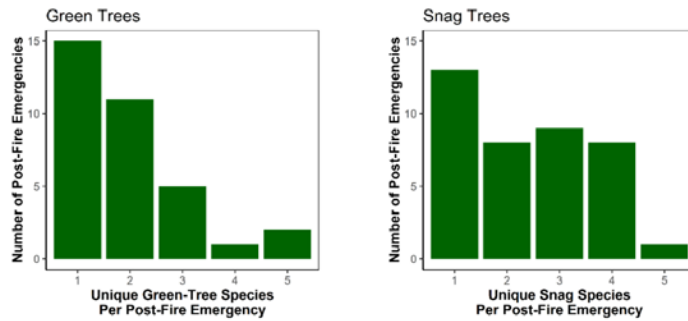
**Figure 14:** Number of Emergencies by number of unique tree species present, for green trees of any type (left), and snag trees of any type (right).
