**MONITORING STUDY GROUP
CALIFORNIA STATE BOARD OF FORESTRY AND FIRE PROTECTION**

Forest Practice Rules Implementation and Effectiveness Monitoring (FORPRIEM) Program

MONITORING RESULTS FROM 2008 THROUGH 2013

**December 2014
SACRAMENTO, CALIFORNIA**

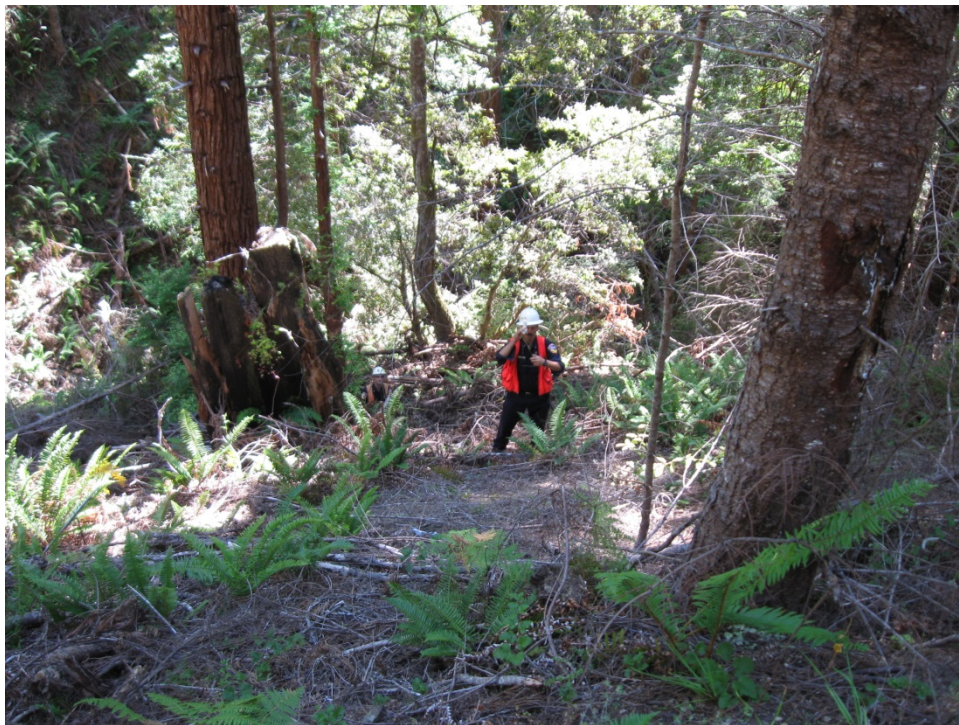
Figure 7. Ken Margiott, CAL FIRE, measures total canopy for FORPRIEM (92%) on August 16, 2011. WLPZ harvesting had occurred as part of this NTMP-NTO (1-97NTMP-018 MEN #6, Mill Creek NTMP).

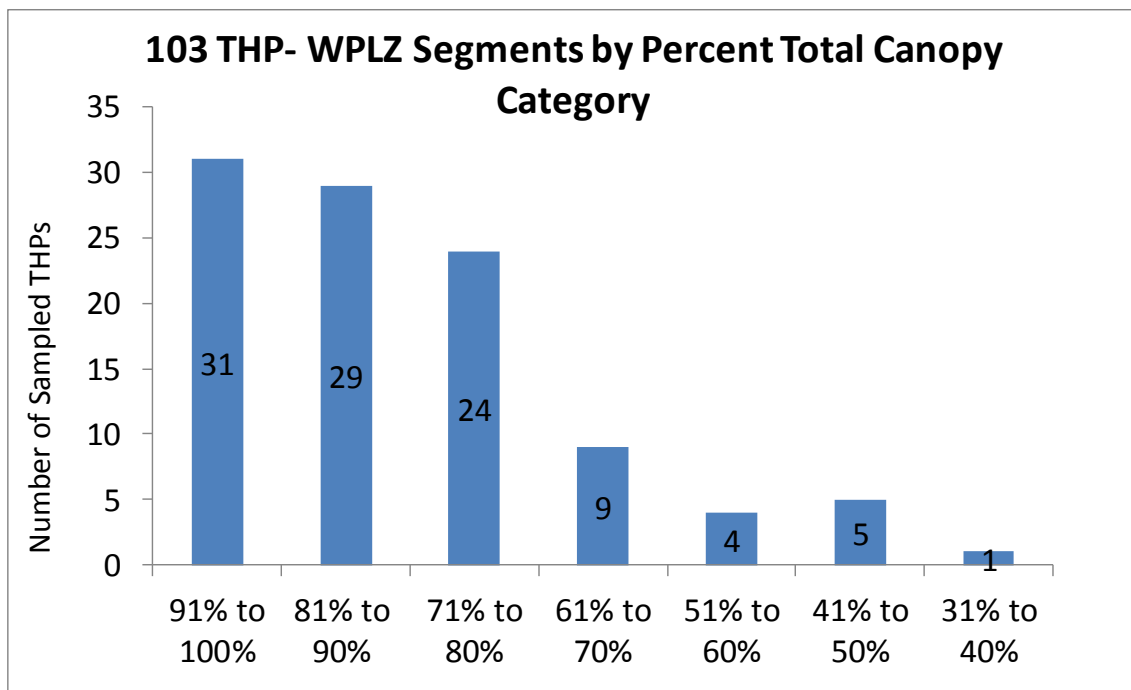
<u>THP</u> WLPZ Total Canopy Overall
Mean = 82% s.d. = 15 n = 103 Median = 84%

Figure 13. Distribution of the 103 THP WLPZ segments by percent total canopy category. There are more segments at the high end of the distribution than at low end. As a consequence, the median is slightly higher than the mean.

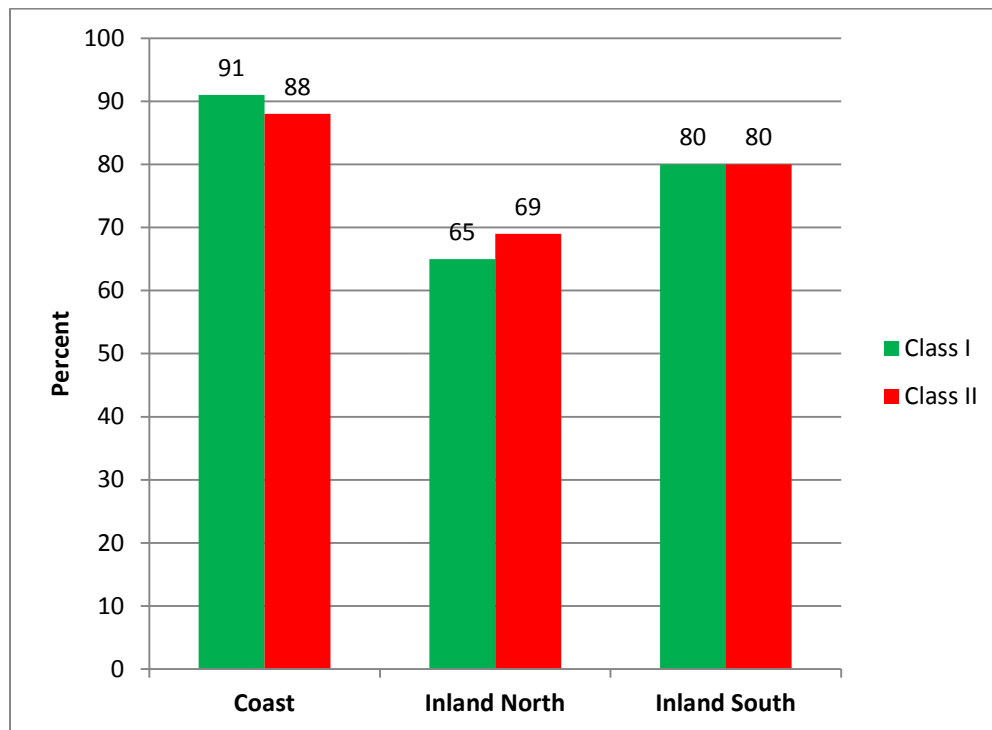
Figure 15. THP WLPZ percent total canopy by CAL FIRE Administrative Area, comparing Class I and Class II watercourses.

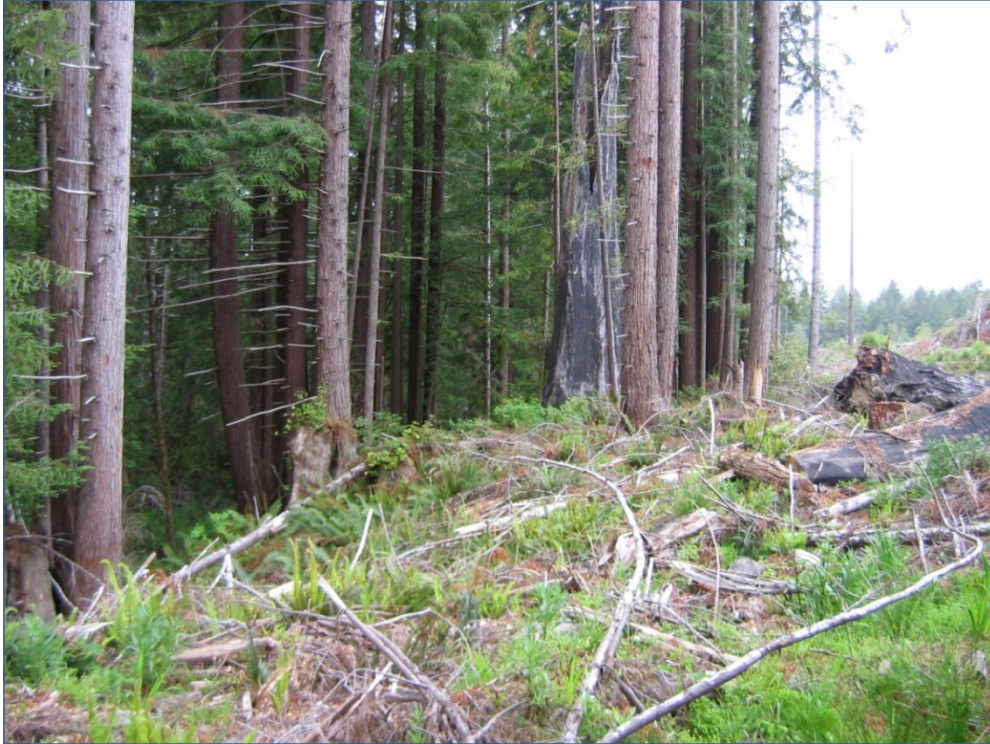
Figure 16. Example of a Coast Region Class II WLPZ in the FORPRIEM THP sample. Total canopy was 82% (THP 01-05-246 HUM).

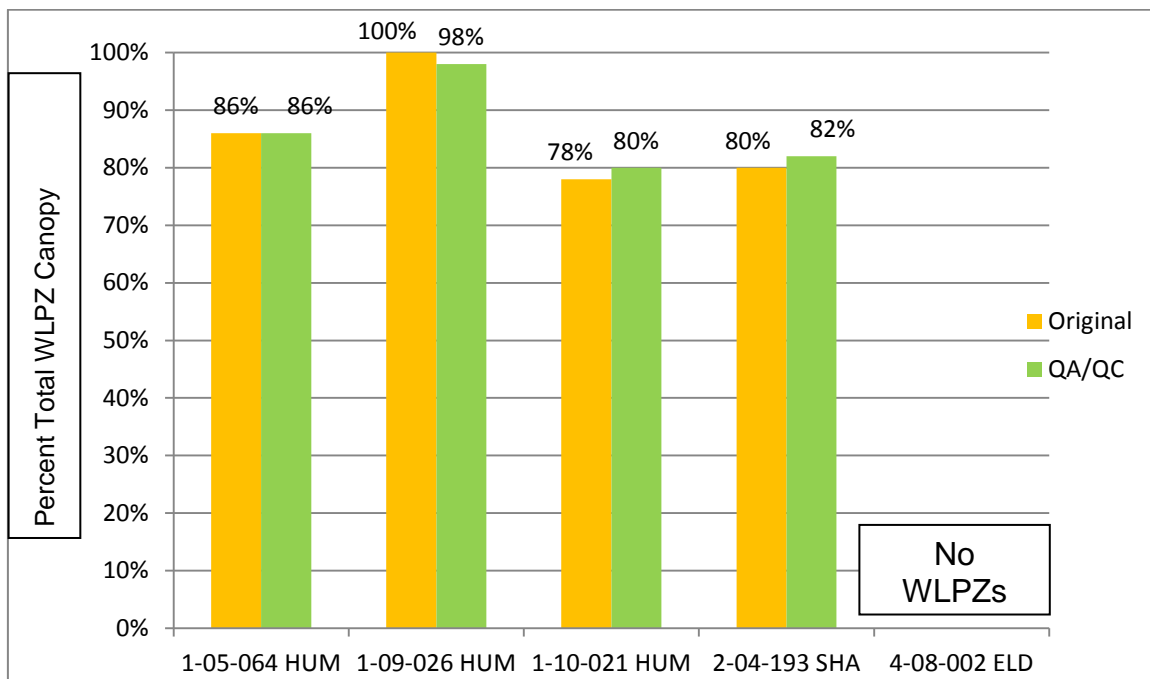
Figure 20. QA/QC – THP WLPZ percent total canopy. Five FORPRIEM-monitored THPs were picked at random for re-monitoring. Four of the five THPs had monitored WLPZ segments.

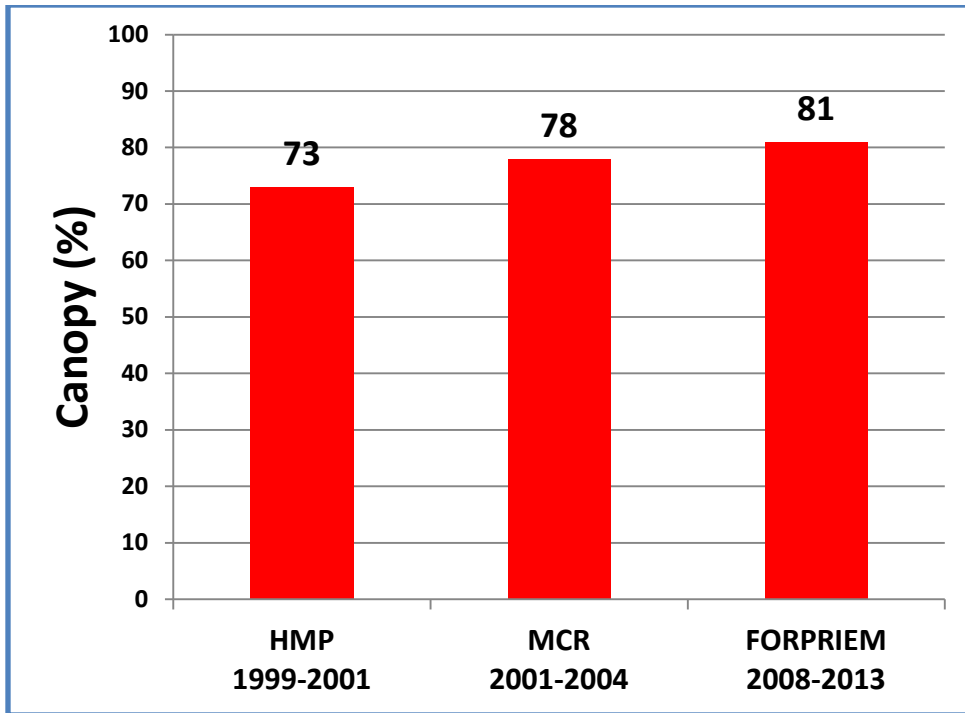
Figure 21. Comparison of THP Class I WLPZ percent total canopy measured with a sighting tube for three studies (HMP 1999-2001, MCR 2001-2004 and FORPRIEM 2008-2013).

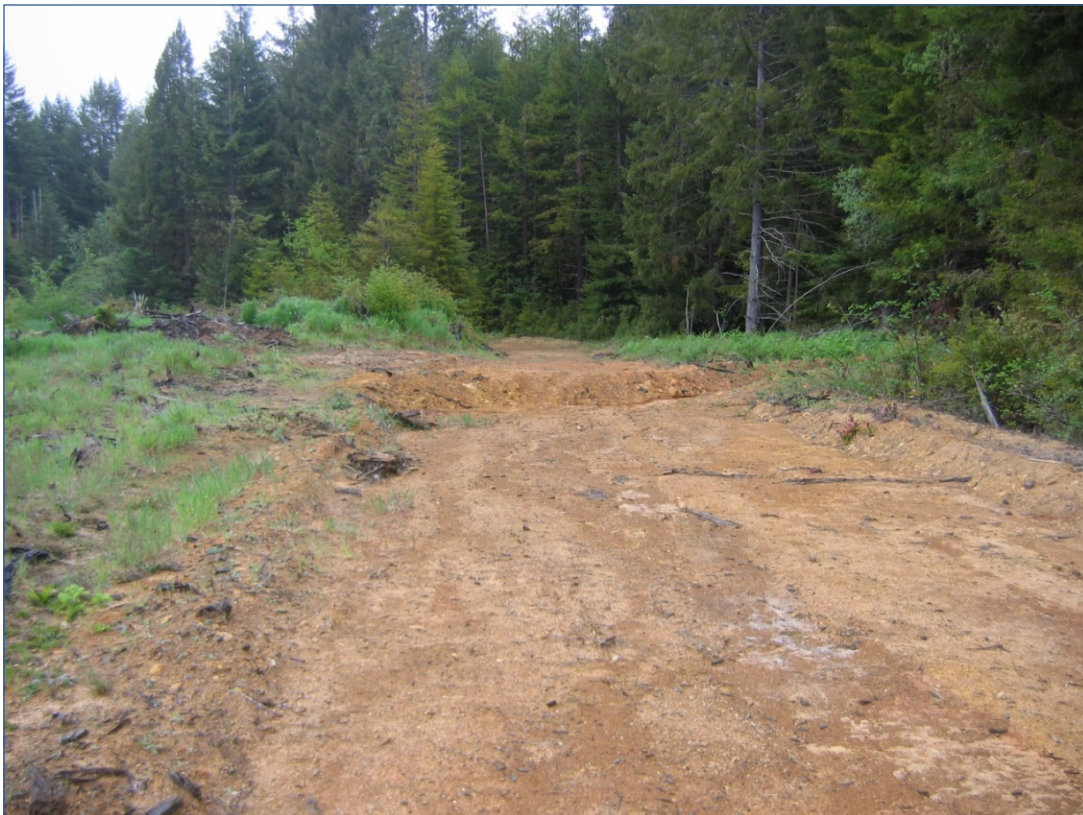
Figure 32. Example of a seasonal road with a properly installed waterbreak (THP in the FORPRIEM sample in Humboldt County).

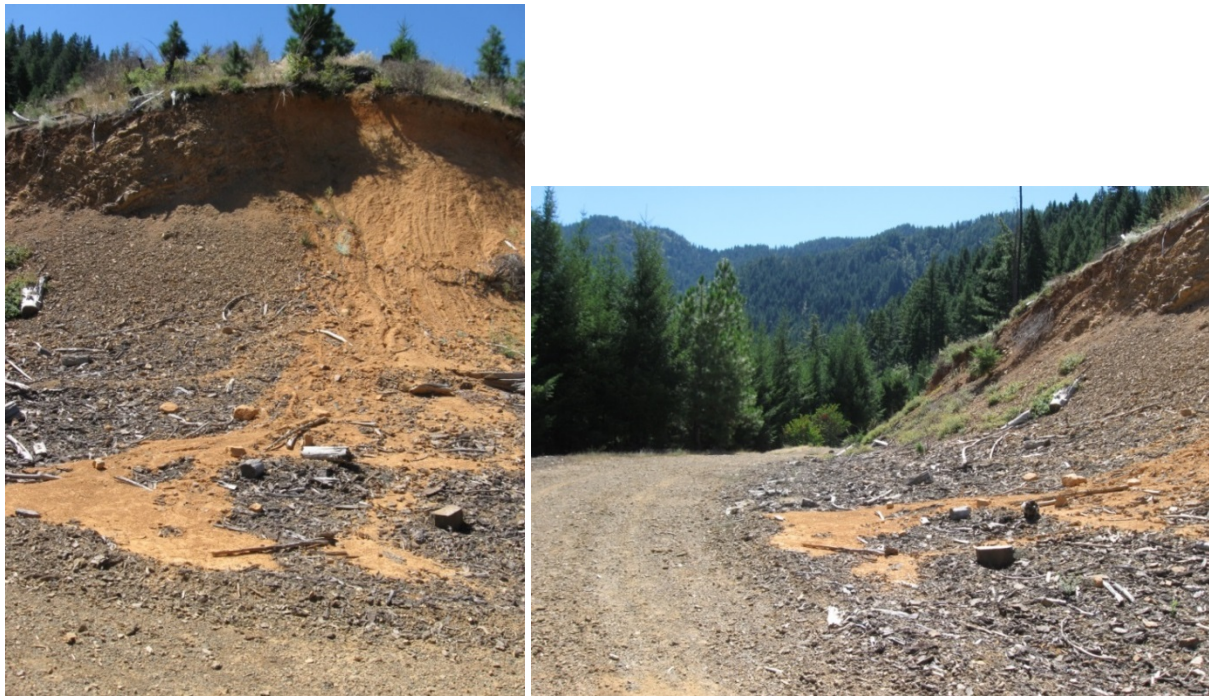
Figure 33. Example of sediment deposition onto a randomly located THP road segment in the FORPRIEM sample.

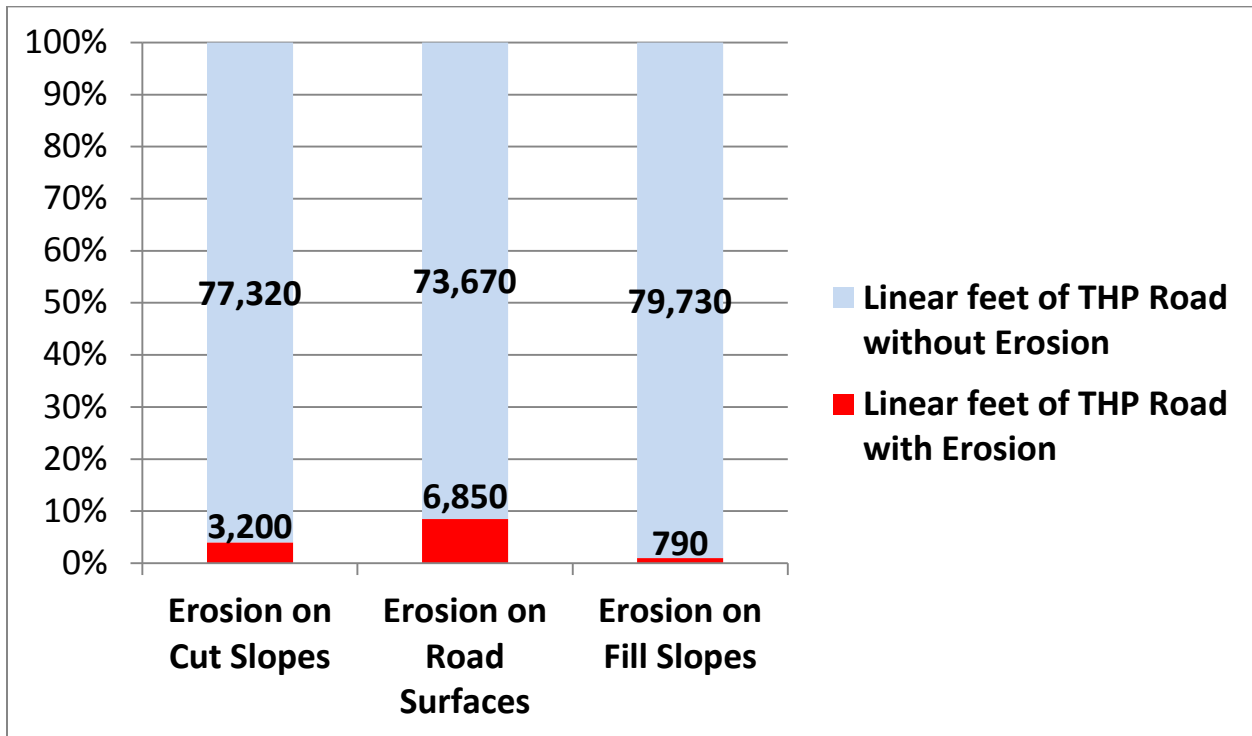
Figure 34. Percentage of the total THP road length monitored with erosion on the cut slope, erosion on the road surface, and erosion on the fill slope.

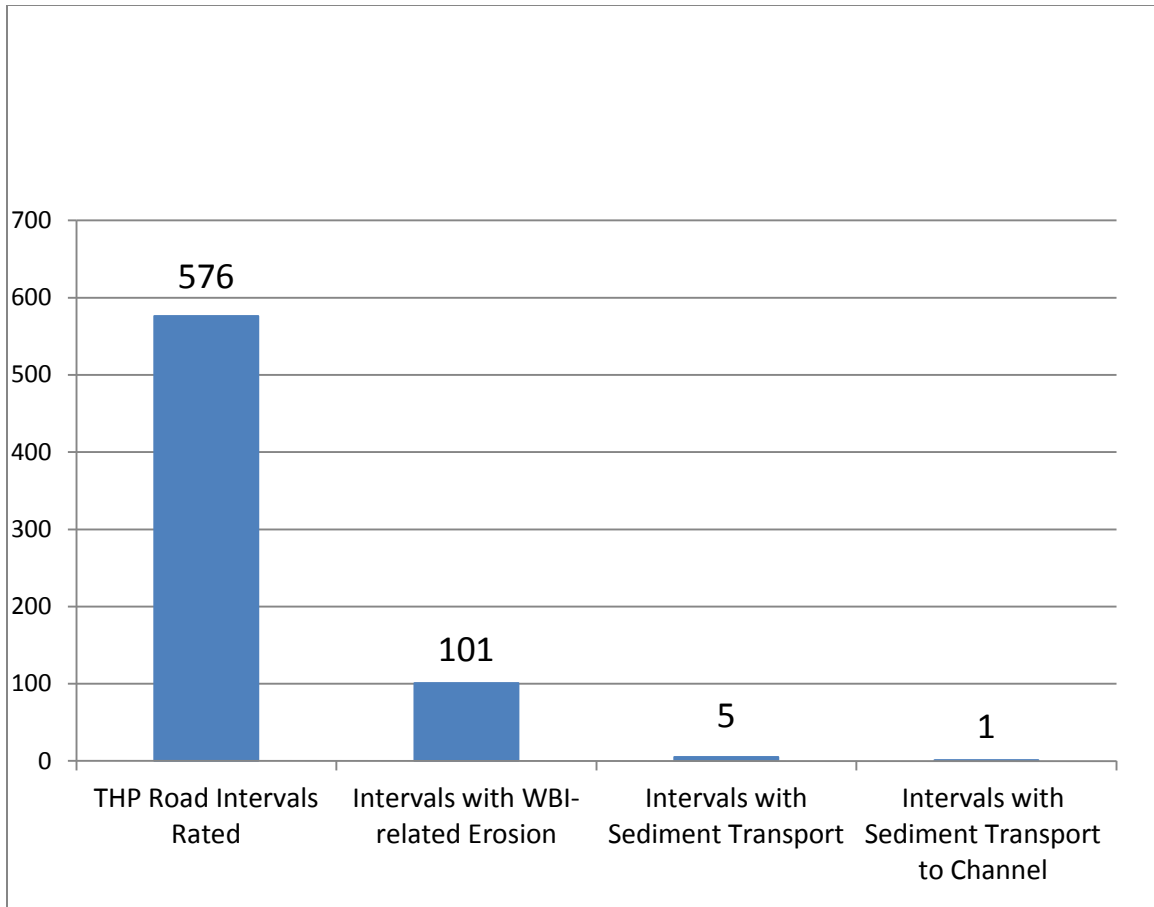
Figure 36. THP road intervals monitored (including both intervals drained by waterbreaks and those drained by inside ditches with insloping) compared to the number with erosion, with sediment transport, and sediment transport to the channel.

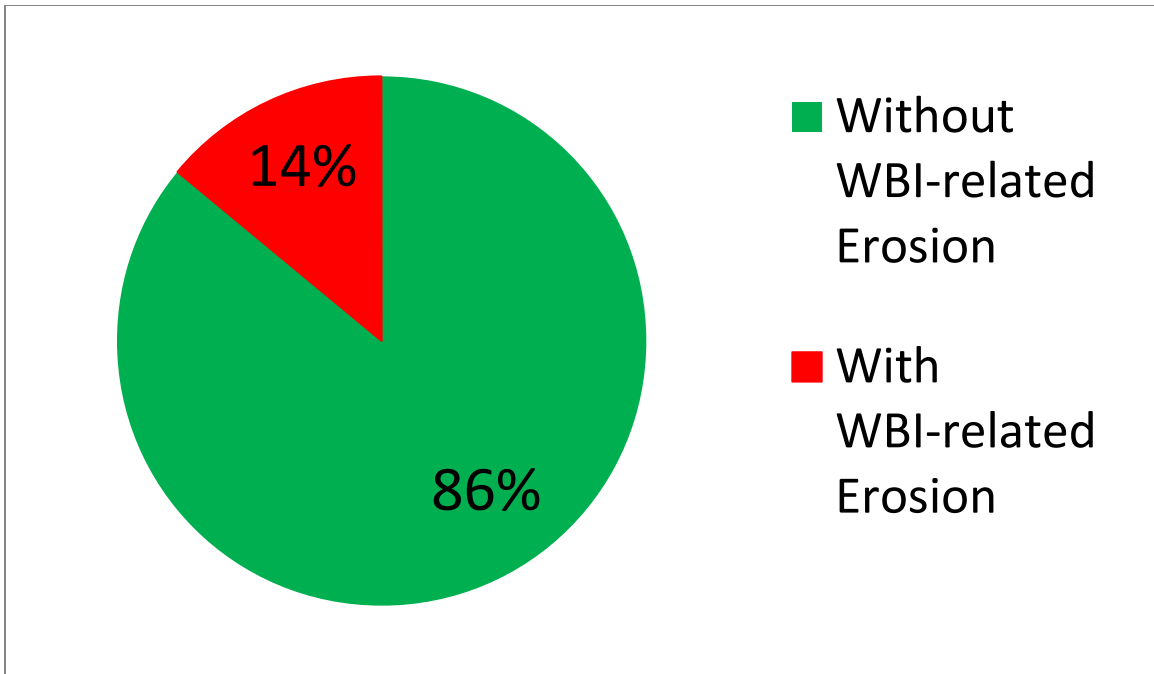
Figure 37. THP random road segments with correct waterbreak-interval spacing, and resulting percentages of segments with and without WBI-related erosion features. Does not include five segments primarily insloped and drained with inside ditches.

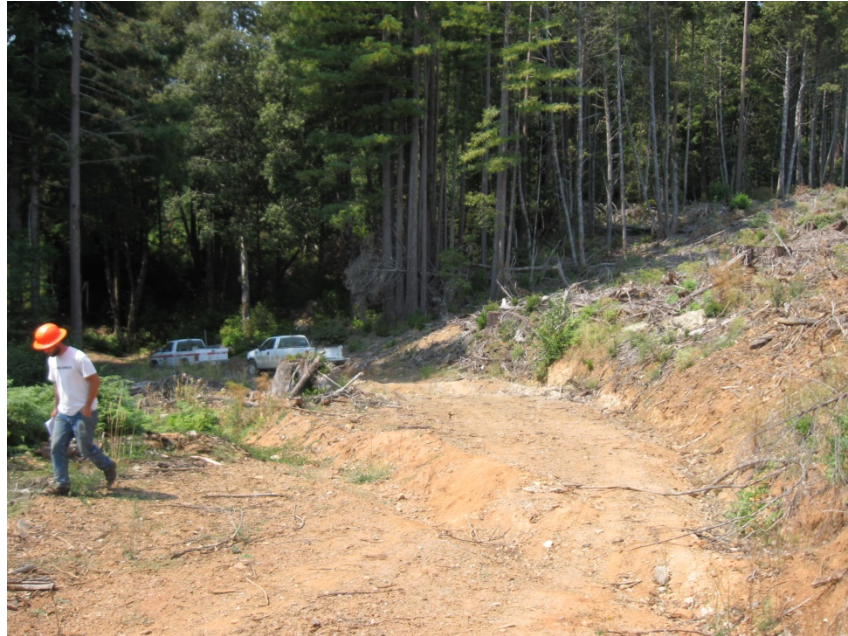
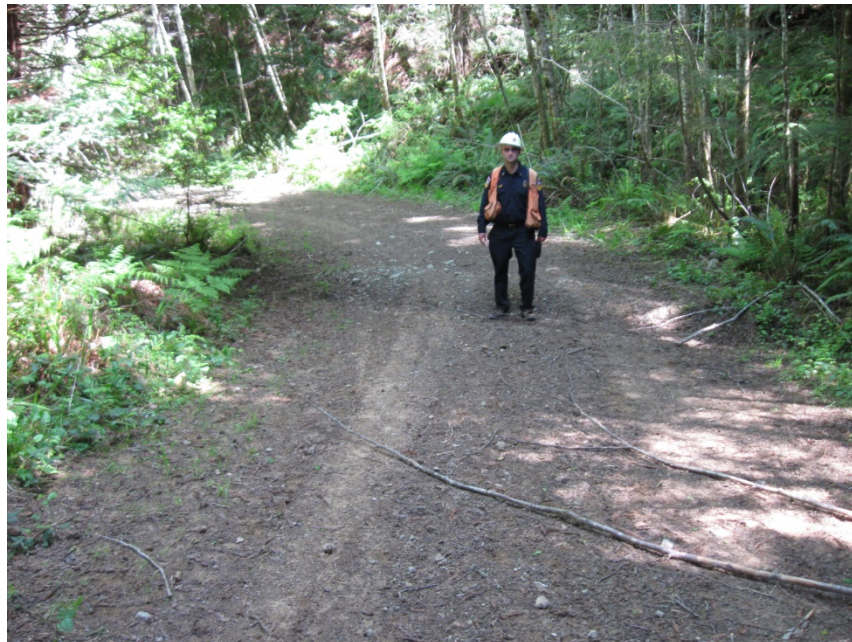
Figure 39. Examples of road segments in the FORPRIEM sample with appropriate road drainage facility spacing and without erosion features.

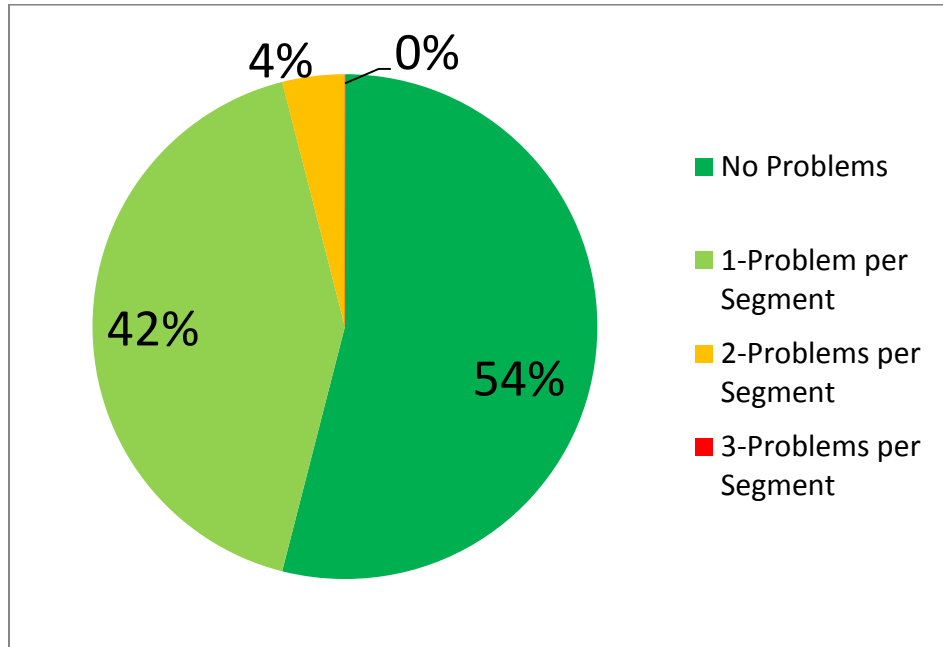
Figure 43. Distribution of NTMP-NTO waterbreak spacing problems by sampled road segment. Forest Practice Rule 14 CCR § 914.6 [934.6, 954.6] (c).

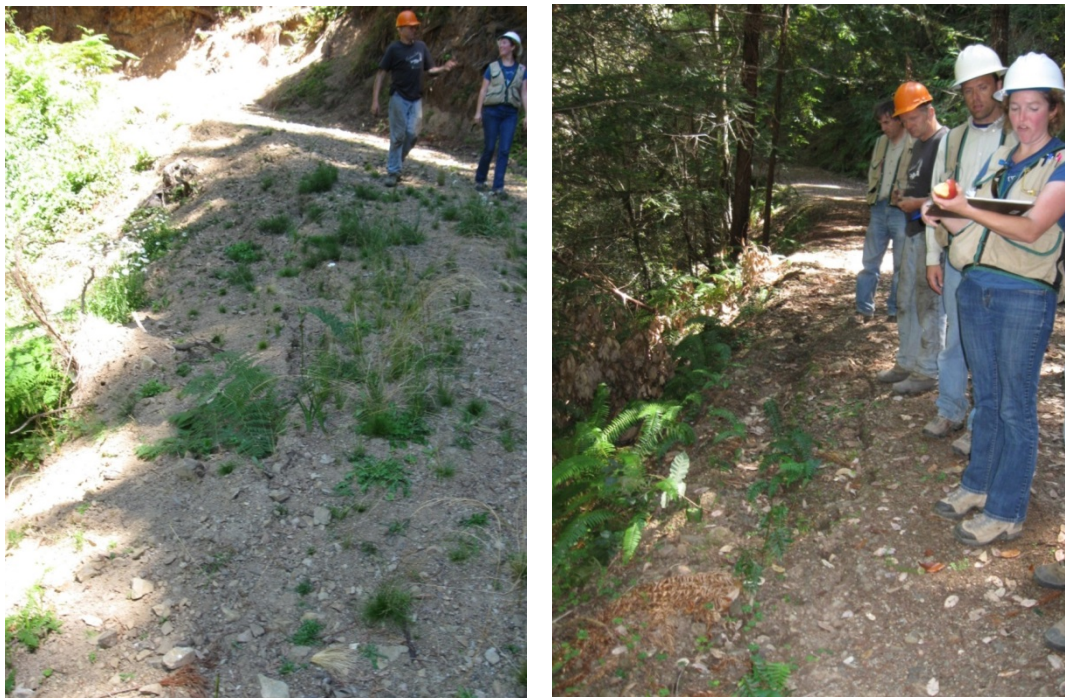
Figure 45. Some of the FORPRIEM monitoring, particularly the NTMP-NTO monitoring, was done jointly with staff from sister agencies, such as the NCRWQCB. These photos show 60 feet of road fill slope erosion on a monitored road transect (left) and tension cracks on the road surface (right).

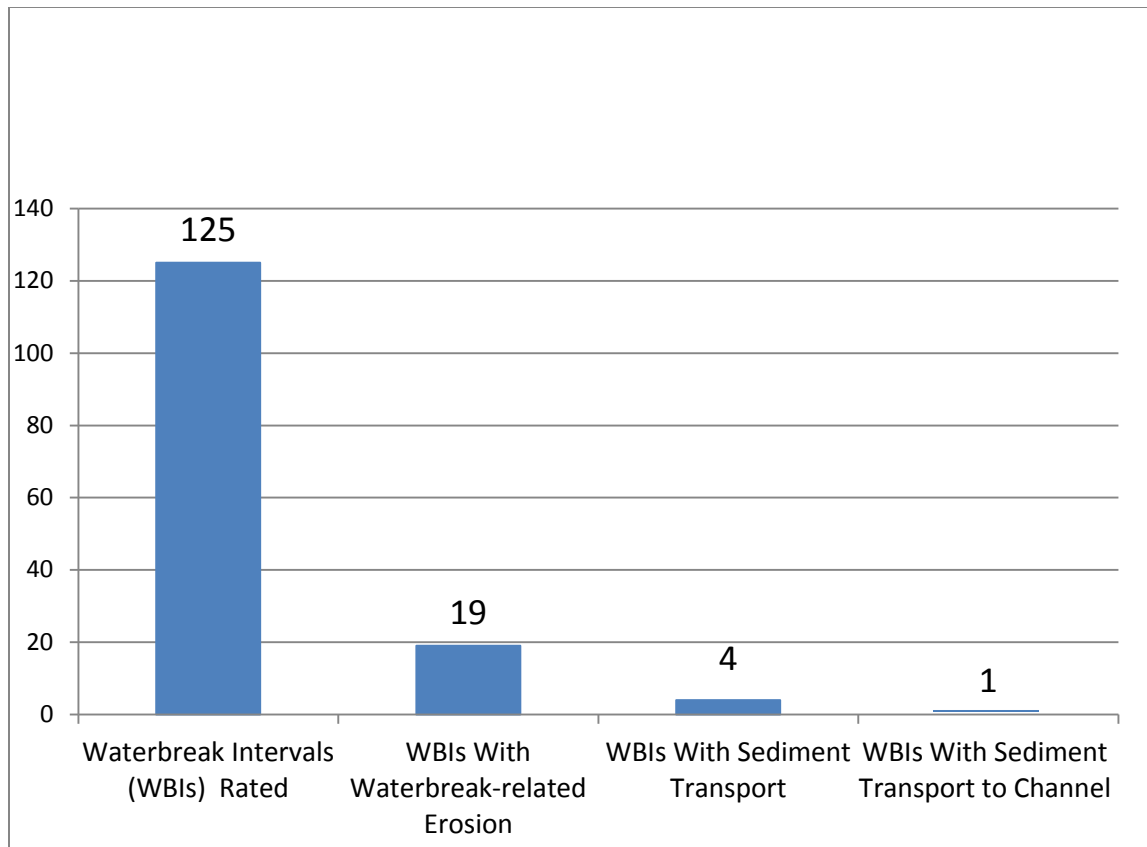
Figure 47. NTMP-NTO road intervals monitored compared to the number with erosion, with sediment transport, and sediment transport to the channel. The WBI with sediment transport to a channel was not related to a problem with waterbreak spacing (Table 11).

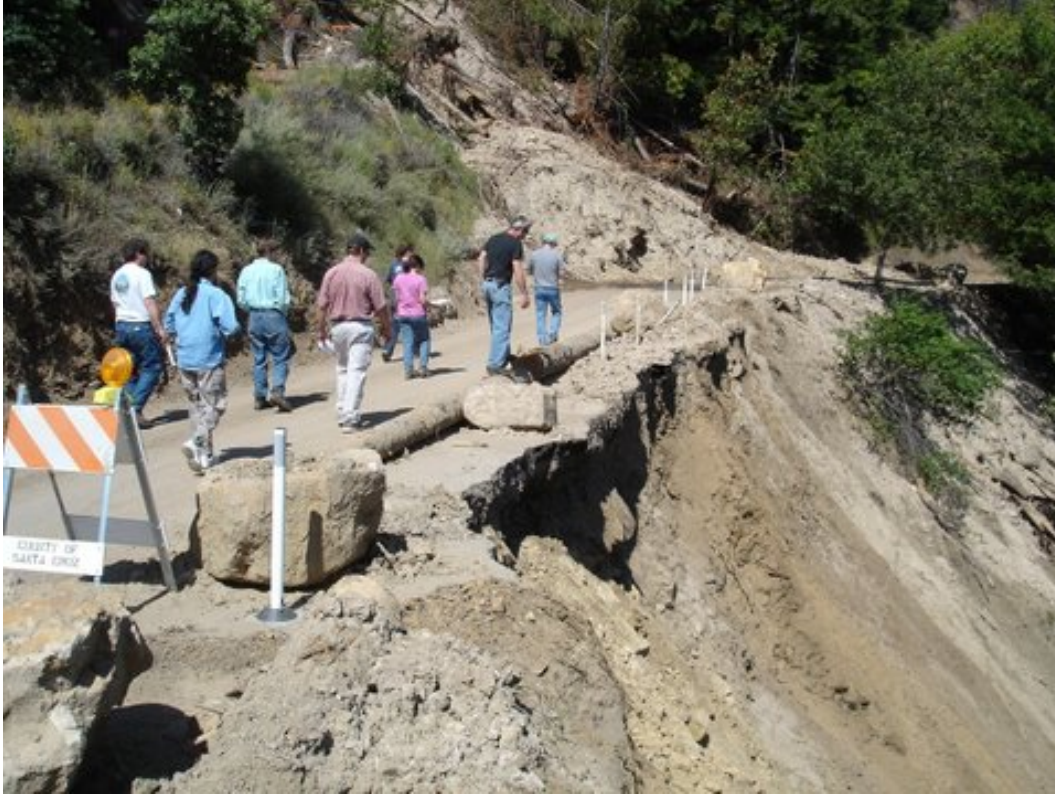
Figure 53. Public roads, such as this road in Santa Cruz County with a major landslide feature, were not included in the FORPRIEM sample.

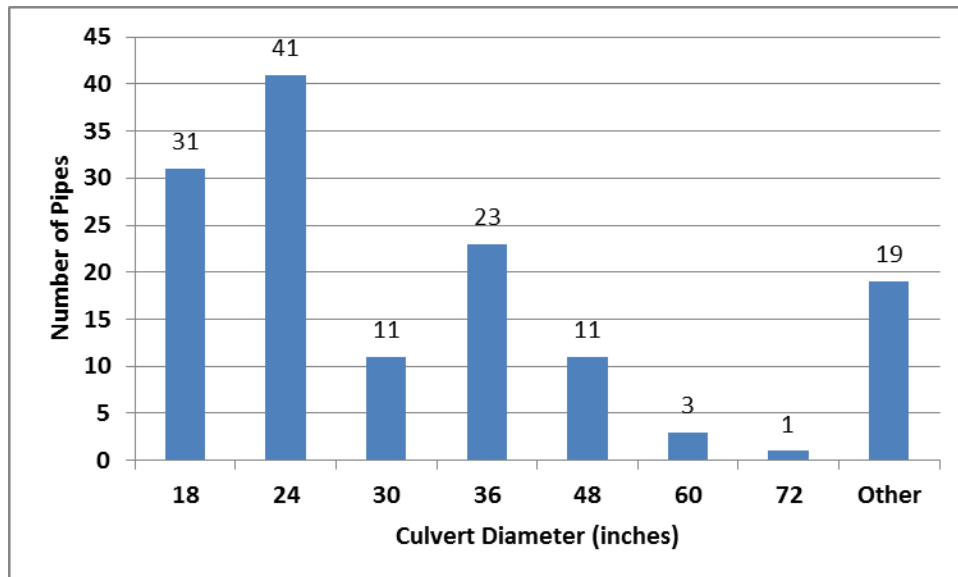
Figure 59. Culvert size distribution for THP watercourse crossings with pipes.

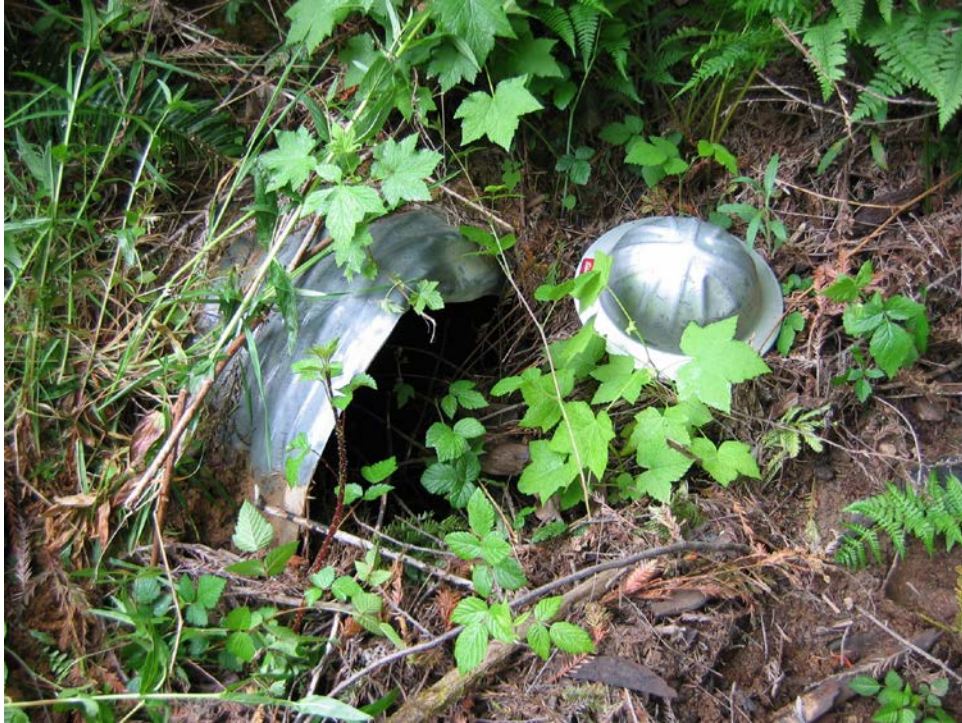
Figure 64. Culvert crossing with sediment and debris blocking more than 30% of the inlet (major problem), THP 1-05-246 HUM, crossing number 1.

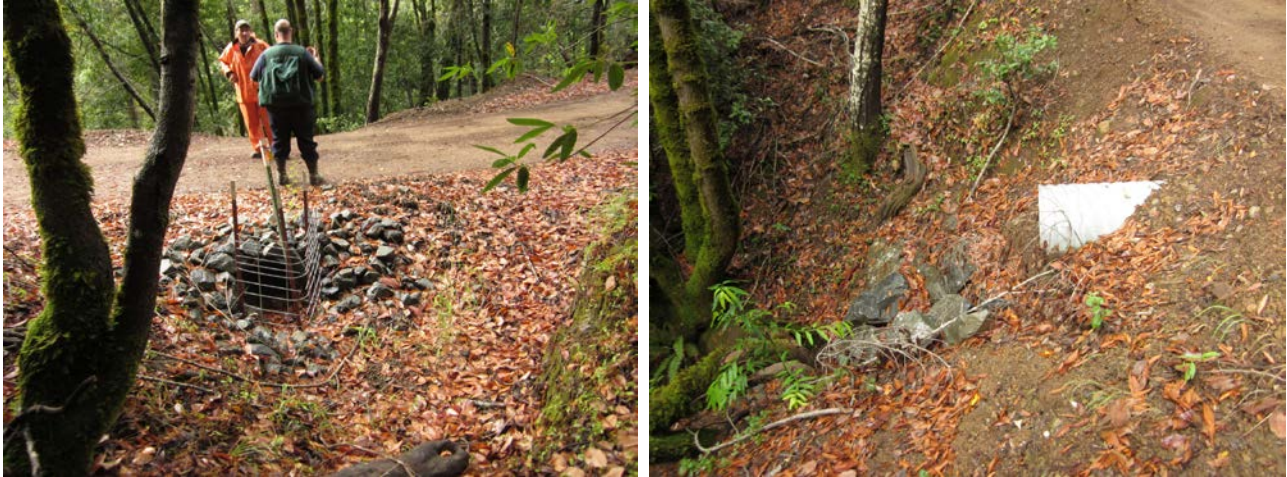
Figure 67. Typical 18 inch culvert (1-97NTMP-038). The crossing inlet is shown on the left; the outlet is on the right.

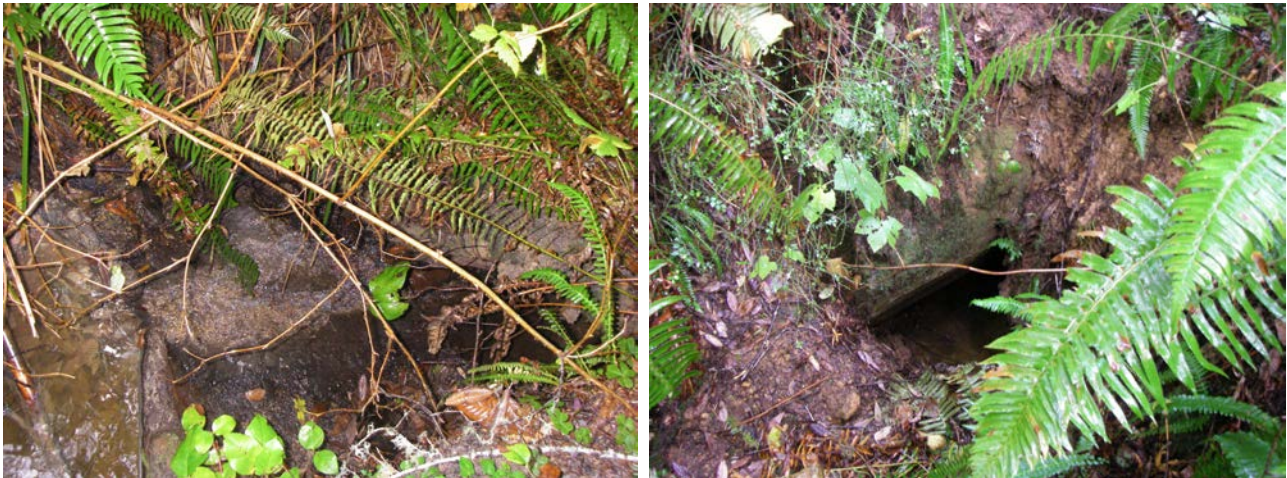
Figure 68. Photos of a Humboldt (log-filled) crossing in the sample from an NTMP-NTO in Mendocino County. The crossing inlet is shown on the left; the outlet is on the right.

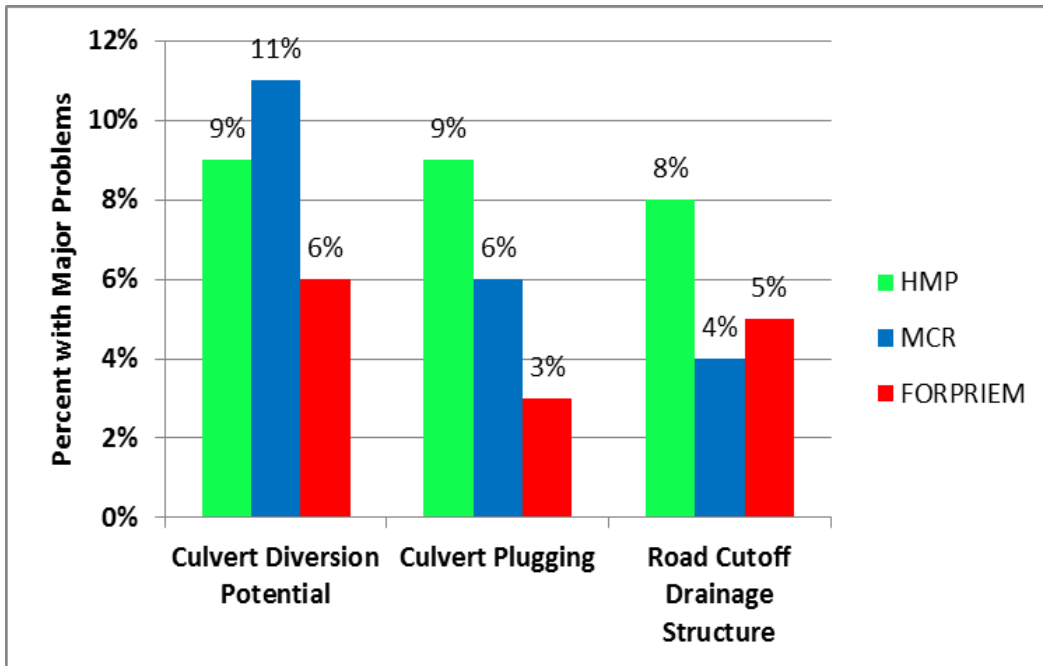
Figure 76. Comparison of three effectiveness categories evaluated with three different monitoring programs spanning 1996 to 2013.

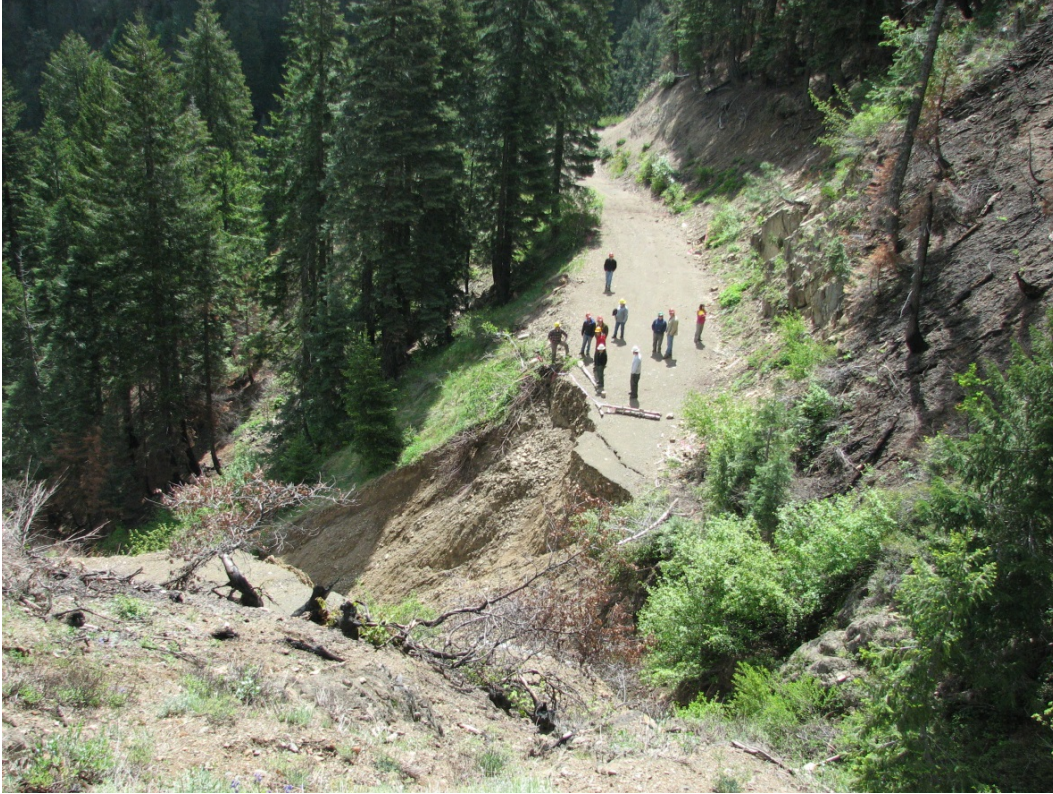
Figure 77. Road fill failure in the Hawkins Creek watershed resulting from the December 2012 storm event (photo from USFS 2013, provided by Juan de la Fuente, Shasta-Trinity National Forest).
