**Final Report**

**Cross-Laminated Timber Layup Tests Using Western  
Wood Products Association (WWPA) White fir Species  
Group**

**TallWood Design Institute**

**June 2021**

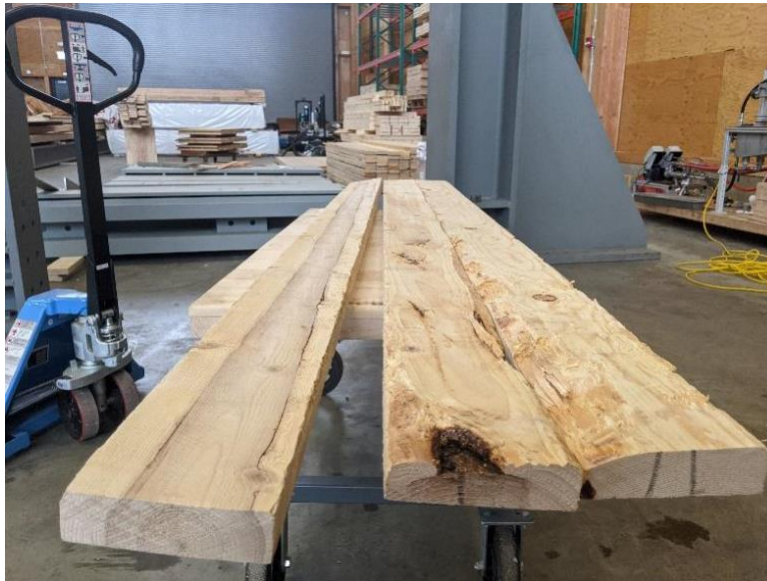
Figure 1: Examples of rejected boards

The boards pictured in Figure 1 were rejected due to extremely poor surface quality and excessive twist.

Individual boards in each unit of lumber were visually inspected for obvious deficiencies such as excessive bow and twist, and for the presence of rock chips and other foreign matter. Sub-standard boards were rejected. Hand-scanning was then carried out with a metal detector to locate staples that had been inserted during the lumber wrapping process.

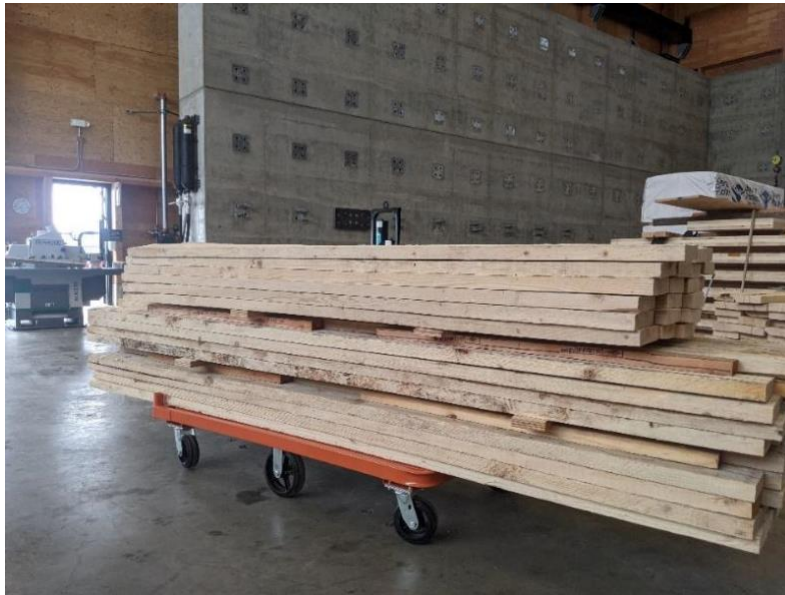
Figure 2: Boards stacked on carts, ready for planing

Once sub-standard boards had been removed, the appropriate number of boards needed for each panel were pulled and placed on carts (Figure 2). 50% of our fabricated CLT test panels consisted of #2&btr throughout the panel, and the remaining panels utilized #2&btr for the outer layers and #3&btr for the middle layer. To manufacture one 8' x 10', 3-ply CLT panel (24) 8' boards and (38) 10' boards (19 boards for each face) were needed. Based on the sorting process approximately 283 boards had to be culled due to defects, which was approximately 2 units of wood.

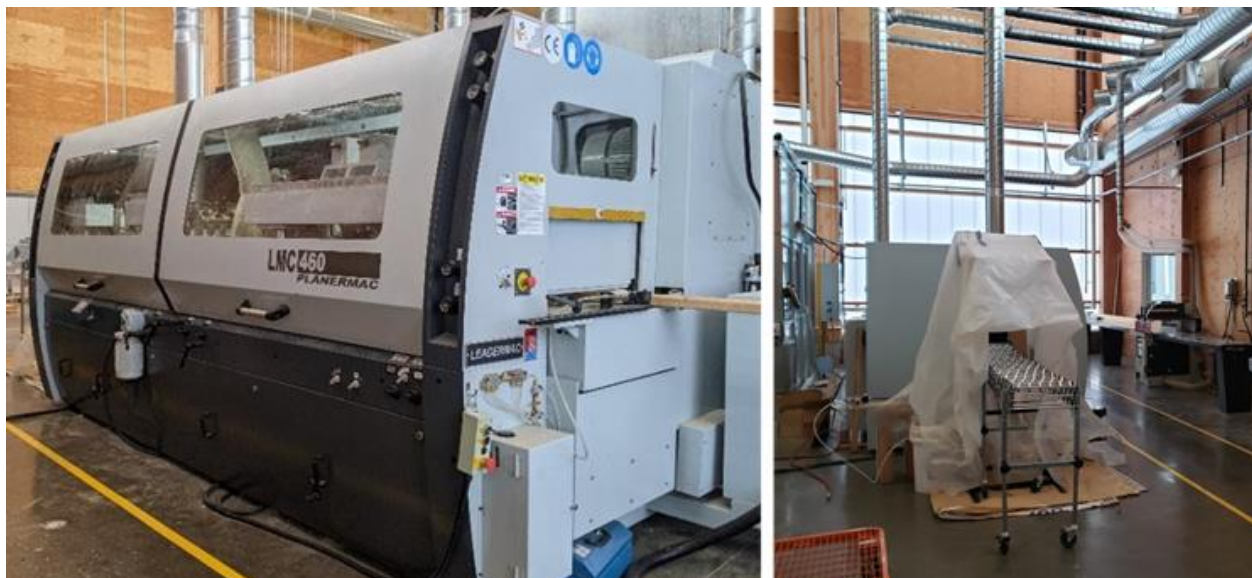
Figure 3: Leadermac Planer (left) and primer setup connected to the outfeed of Planer (right)

Once all of the material was sorted, it was then taken to be planed and primed to approximately 1.375" in thickness and 5.15" width. A Leadermac LMC 460 planer was used to plane the lumber (Figure 3)

At the end of the outfeed of the planer a priming system was set up to apply the adhesive primer (Figure 3). A Henkel primer was applied at a spread rate of  $2\text{g}/\text{ft}^2$ , according to Henkel's instructions (Loctite PR 3105)<sup>[1]</sup>. The boards were then allowed to dry for 1-2 hours.

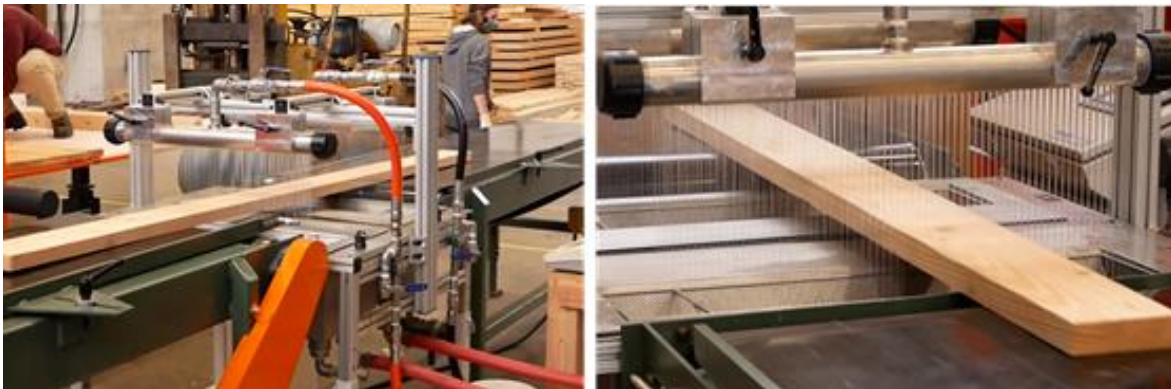
Figure 4: Resin Applicator

We fabricated the CLT panels using a Henkel polyurethane adhesive (Loctite HB X602 Purbond)<sup>[2]</sup>, which was chosen based on its compliance with the California Air Resources Board (CARB) standards. The recommended spread rate of  $28\text{ lbs}/1000\text{ft}^2$  was verified by weight prior to resin application. A custom-made Apquip resin applicator was used to ensure consistent spread rate throughout the panel. The individual lumber boards (known as *lamella* in CLT manufacturing) were placed on a belt conveyor that passed underneath a curtain of resin.

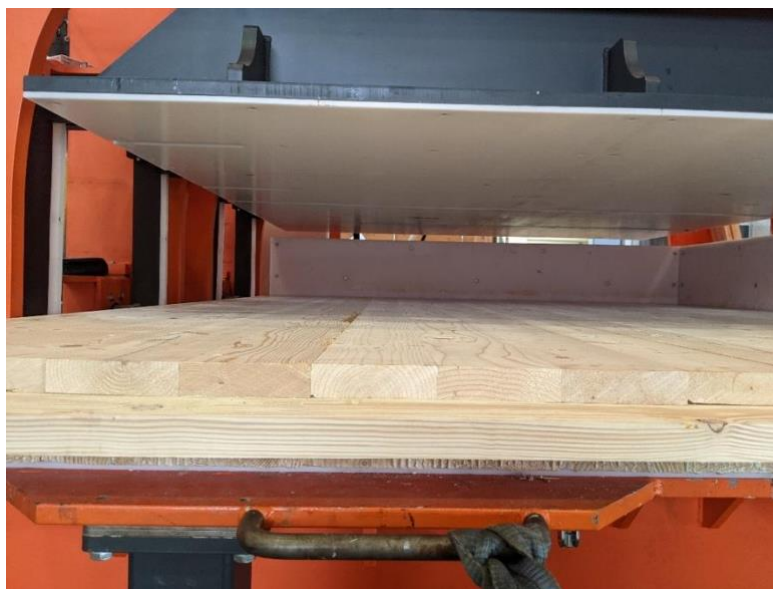
Figure 7: CLT panel immediately after pressing

Once all the boards were placed in the press, the press was closed and set for the required pressure of the PUR adhesive, which was 120 psi (Figure 1c). The press used was a custom-built Minda CLT press which is equipped with 12 linear actuators (Figures 5 and 6). Figure 7 shows a completed panel exiting the press.

The close time for the press was approximately 4 hours. The approximate time taken to complete the entire process to create one panel was around 6-7 hours.

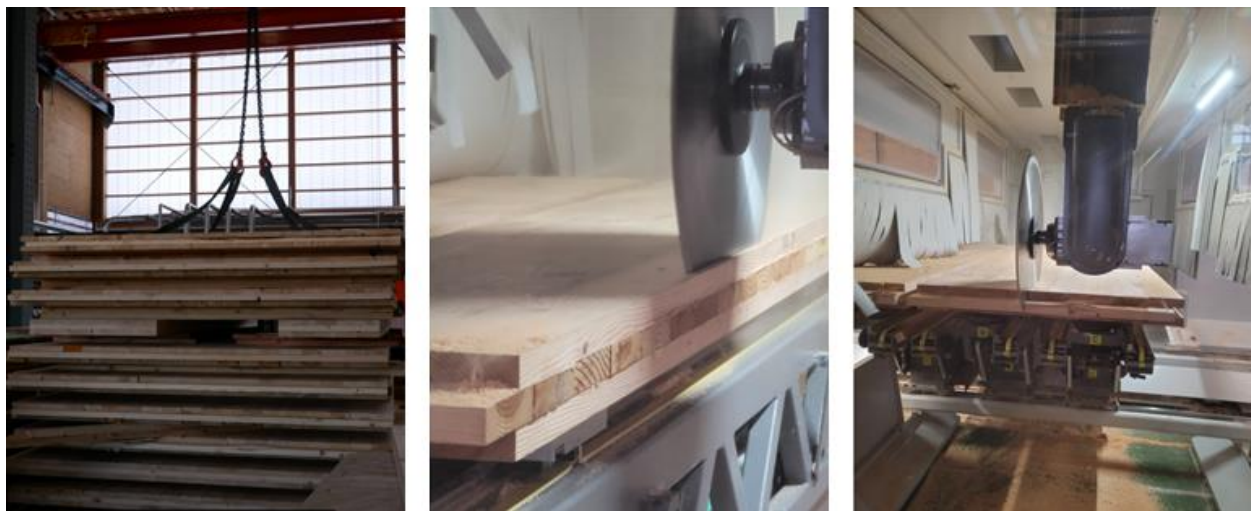
Figure 8: (Left) CNC panels about to be lifted into CNC, (Center) CNC performing ripping operation on panels, and (Right) CNC performing cross-cutting of panels

The processing of the CLT panels was performed on a Biesse Uniteam UT-9 five-axis computer numerical control (CNC) machine (Figure 8).

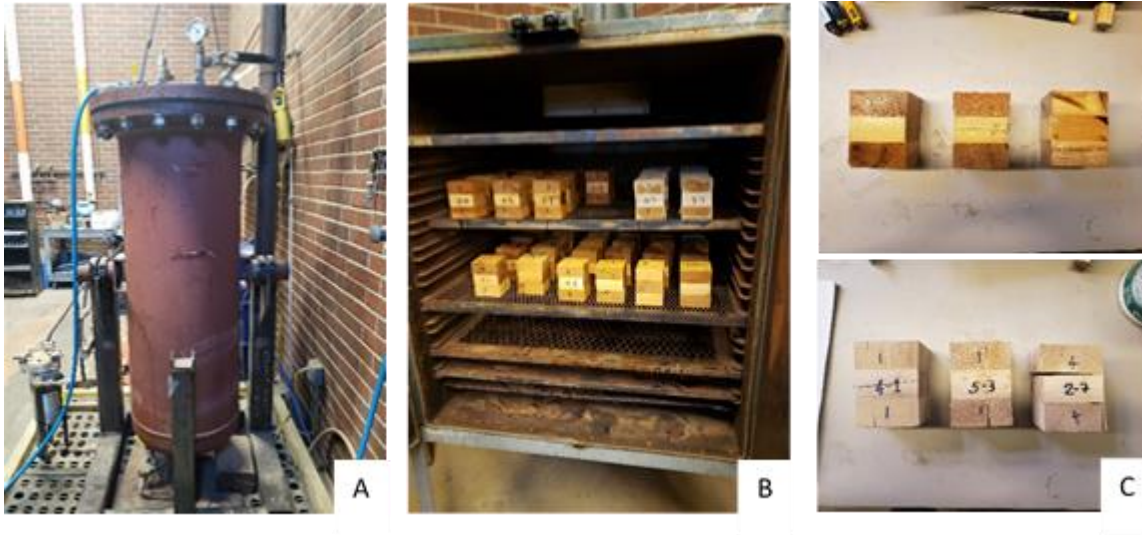
Figure 12: (a) Vacuum/Pressure Vessel, (b) Air Circulating Oven with Samples, and (c) Top: Samples after soaking, Bottom: Samples after drying

The testing utilized a single soak-dry cycle, using a pressure/vacuum vessel and an air circulating oven (Figure 12). The testing procedure began by recording the initial weights of the samples before placing them into the vessel. The samples were then submerged in water and then had a vacuum force applied for 30 minutes at approximately 12.3 psi. Once the 30-minute vacuum had elapsed the vessel was then pressurized for 2 hours at approximately 75 psi. After the pressure cycle was complete the samples were removed from the vessel and placed into an air circulating oven at 160°F. The samples would remain in the oven until they reached approximately 15% of the sample's initial weights. The drying process took approximately 10 to 15 hours for the samples to dry down to 15% of their initial weight.

Once the samples were dry, they were analyzed for delamination. The bond line of each sample was examined for any delamination and then marked and measured. Samples that contained defects such as knots were omitted from the totals, as per the guidelines in the PRG-320 standard. A percentage was calculated based on the measured delamination and the total length of the bond line. The averages for the panels can be seen in Table 3. In the table the samples' average delamination percentage for the top and bottom bond lines is shown. The full results for each specimen and each bond line can be seen in Appendix B.

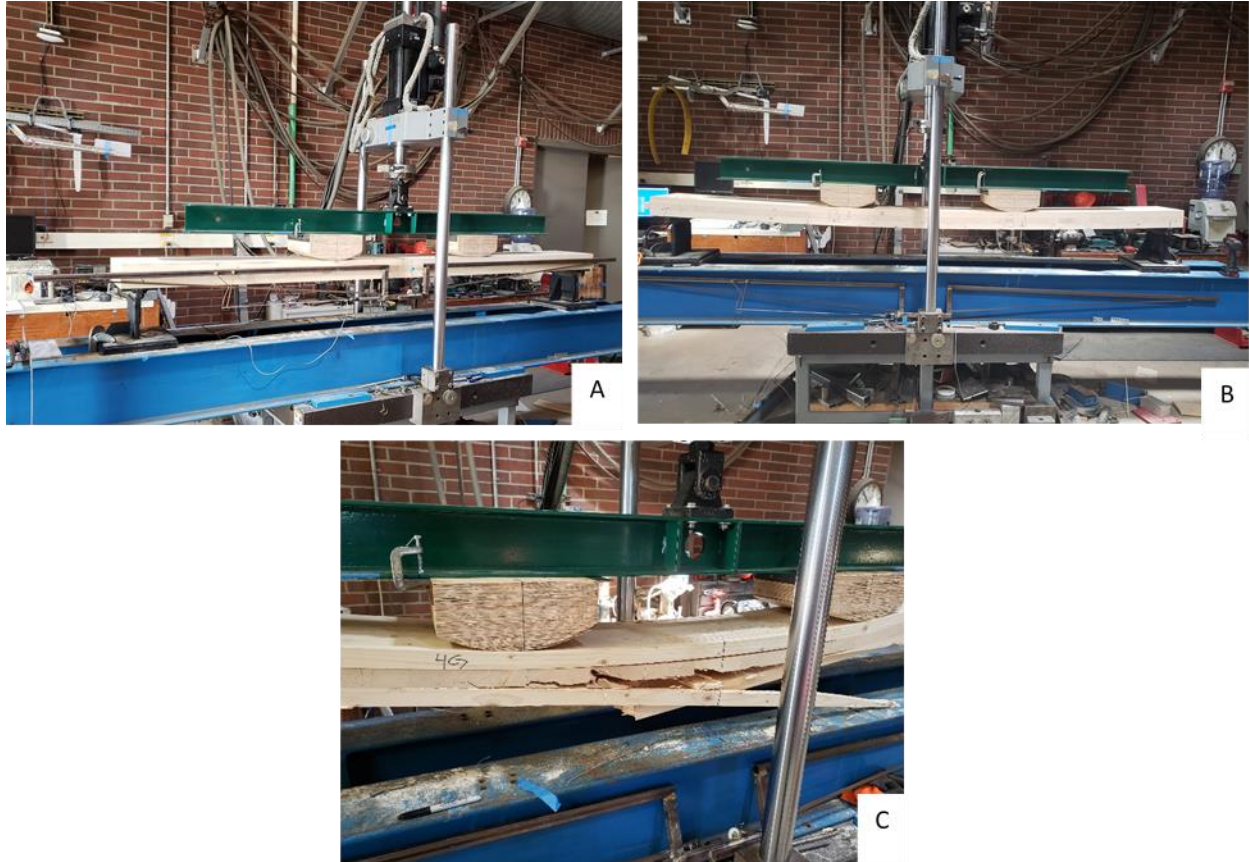
Figure 13: (A) Test Specimen, (B) Test specimen after bridge is removed, and (C) Tension failure of Specimen.

The long-span flexure test specimens used the 12" x 120" strips that were cut from each panel. The samples were tested in 3<sup>rd</sup>-point bending following the ASTM D198-15 Standard Test Methods of Static Tests of Lumber in Structural Sizes. The samples were tested as a total span of 114" with a mid-span of 38" (1/3 of the total span). The center deflection of the samples was measured with a Linear Variable Differential Transformer (LVDT) attached to a yoke that spanned the entire sample (Figure 13). The samples were tested at a rate of 0.25 in/minute until failure, and had the actuator deflection, center deflection, load, and failure type recorded.

The recorded data was then used to calculate the Modulus of Rupture (MOR) and the Modulus of Elasticity (MOE),  $E_{app}$ . Formula 1 is the calculation for the MOR:

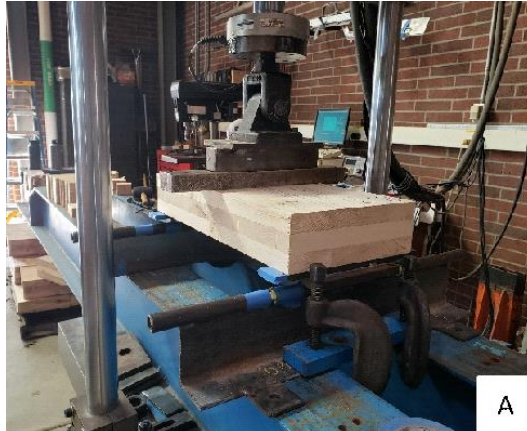
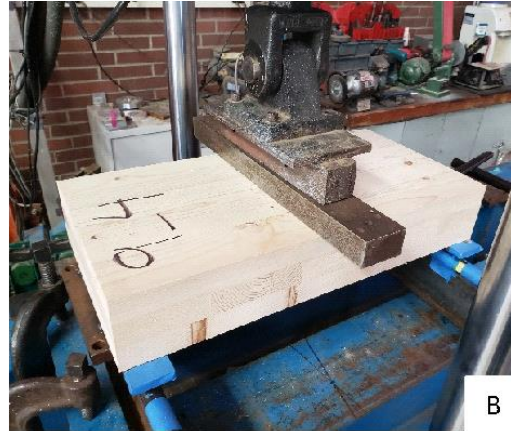
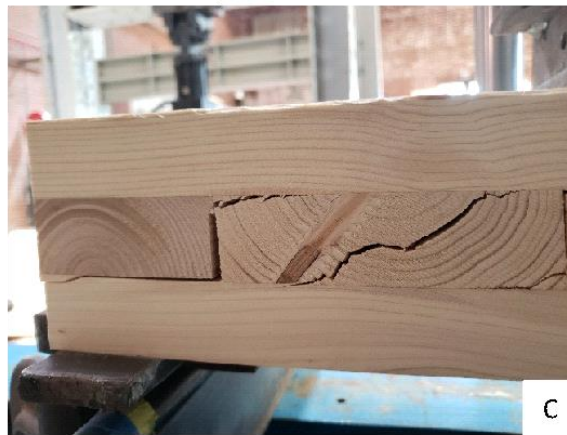
Figure 14: (A) and (B) short span testing setup side and top view, respectively. (C) Typical sample failure, failing in shear

The short-span flexure test specimens used the 12" x 24" strips that were cut from each panel. The samples were tested in center point bending following the ASTM D198-15 Standard Test Methods of Static Tests of Lumber in Structural Sizes. The testing used a span to depth ratio of 5.3:1, making a span of 22". The samples were tested at a rate of 0.1 in/minute until failure, and had the actuator deflection, load, and failure type recorded.

The overall average for the short-span shear strength was approximately 308 PSI with a coefficient of variation of approximately 14%. The samples all failed in shear near or at the bond line, with many showing rolling shear as seen in Figure 13c. Similarly to the long-span testing, the two different grades showed little difference in their average shear strength, with 2&btr at 319 PSI and 3&btr at 296 PSI.
