Santa Cruz Mountains Post-Fire Redwood Defect Study

Nadia Hamey, Hamey Woods

CZU Lightning Complex Fire

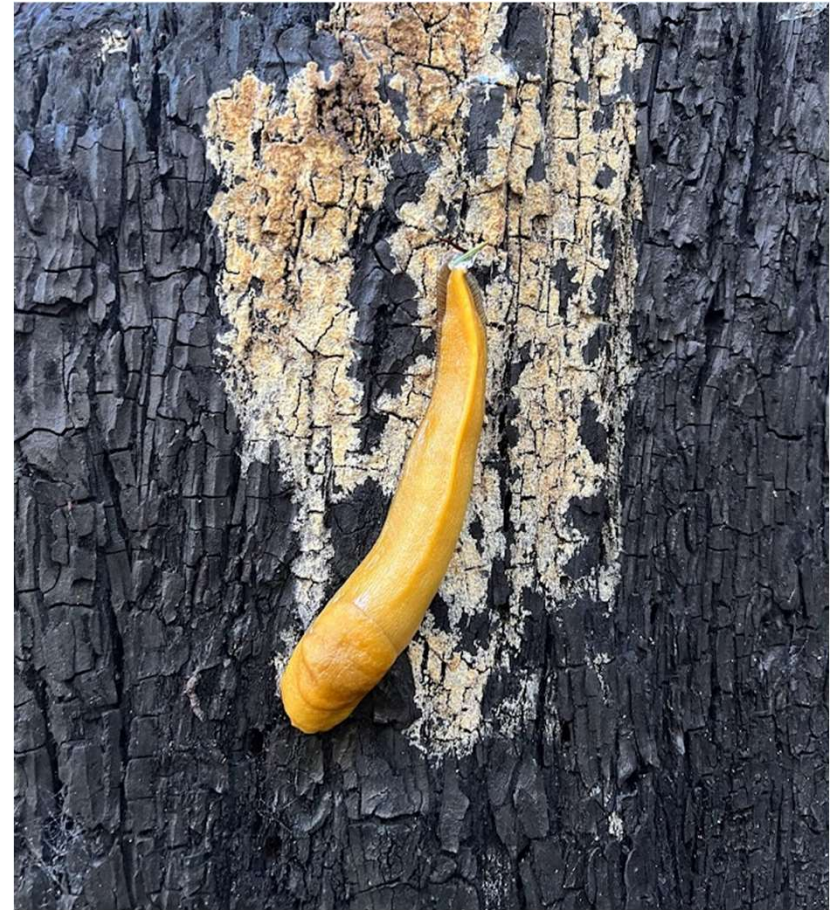
Coniophora puteana, 'wet rot'

- Brown wet rot at base of stem
- Needs high water content (50-60%)
- **Signs:** No external indicators unless host is injured
 - Brown-black Mycelial cords
 - Cream-brown center bounded by white margins

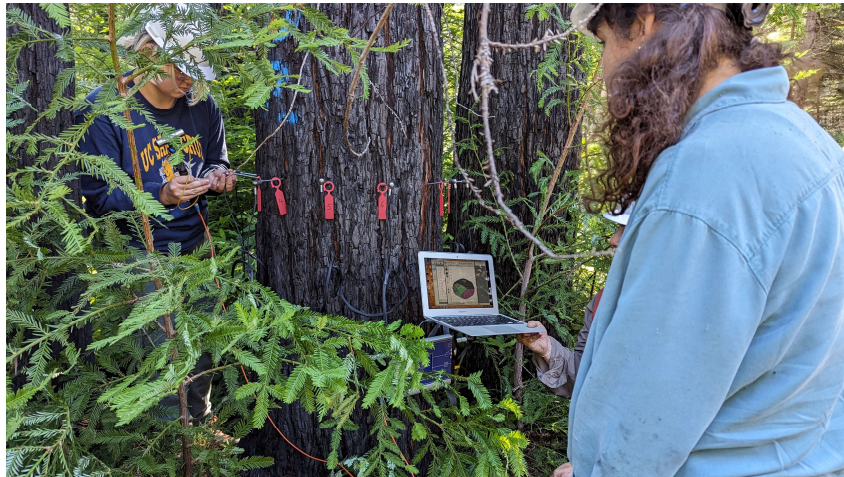
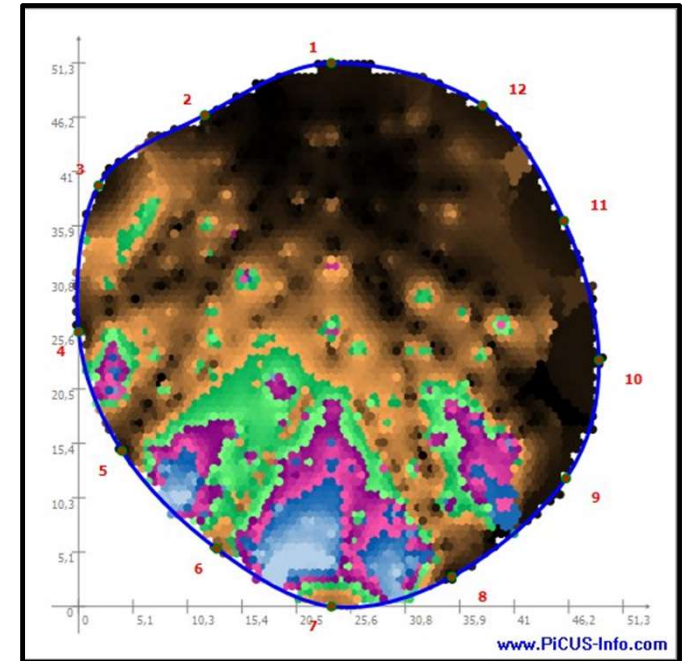
Sonic tomography

- Noninvasive technology, PiCUS 3 Sonic Tomograph
- Structural integrity at 1m from base
- Measures velocity of sound
- Sound travels faster in solid wood

■ = Decay ■ = Healthy
■ = Severe Decay

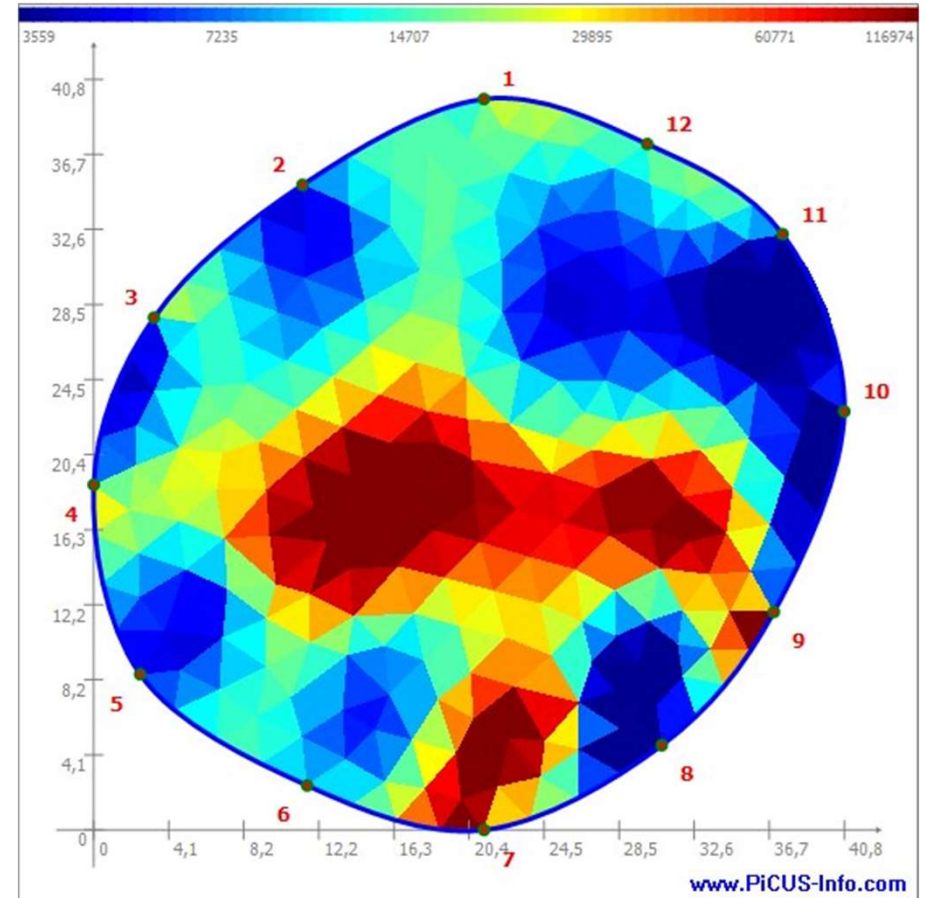
Electrical impedance

- Noninvasive technology, PiCUS tree-tronic
- Scan shows the water content of the same cross section
- Develop electrical conductivity 'map'

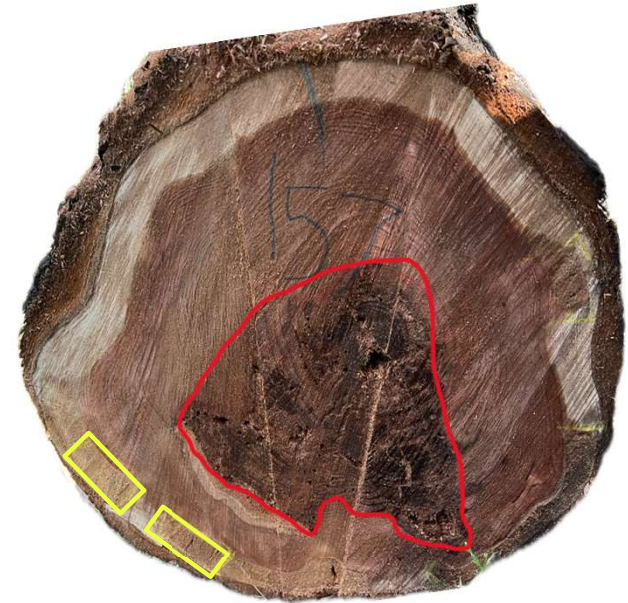
Cross-section

= Sapwood Rot

= Heartwood Rot

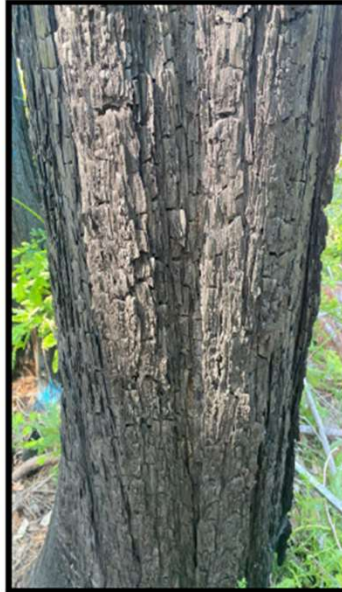
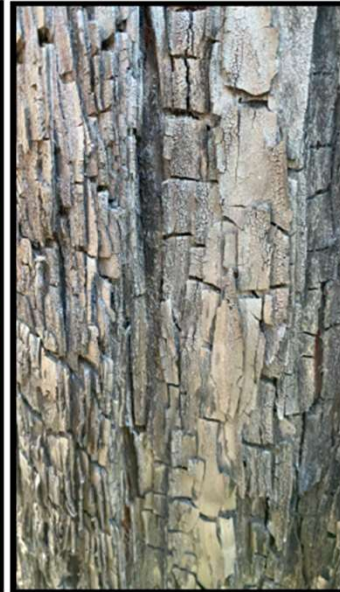
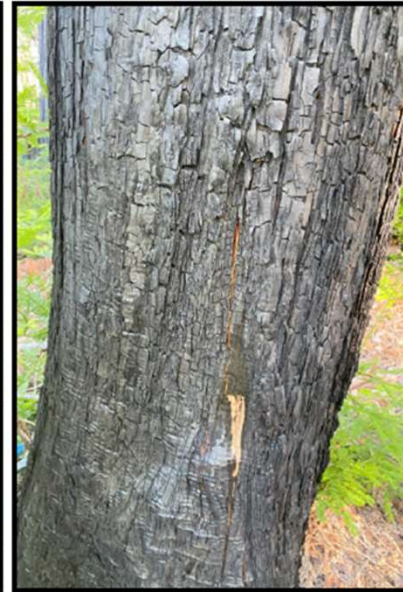
Full Tree and Fungus Photos

- ~64 sq. in of white rot
- ¼ quadrants of fungus
- ¼ quadrants of dead cambium
- Branch & Bole Sprouting
- Low-Moderate Burn Severity Zone

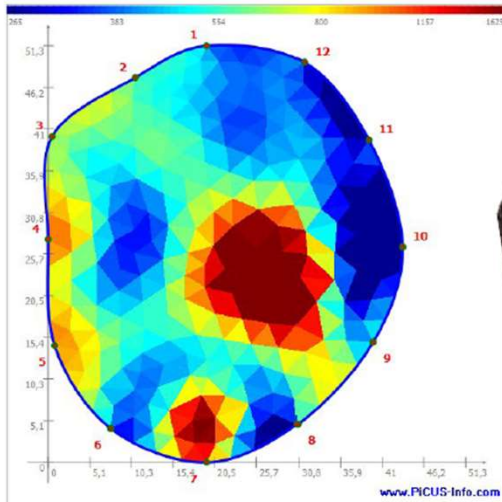
Electrical Impedance Tomography Scan

I = North [] = Sapwood rot

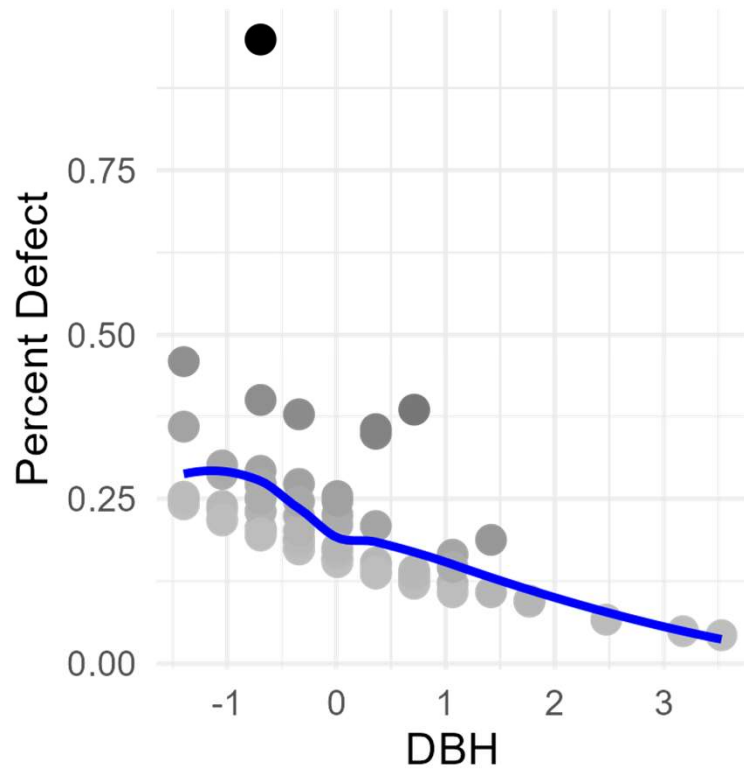
Area of Fungus

Greyscale indicates surface area of fungus
