Draft Final Report

**Cross-Laminated Timber Layup Tests Using Western Wood
Products Association (WWPA) White fir Species Group**

TallWood Design Institute

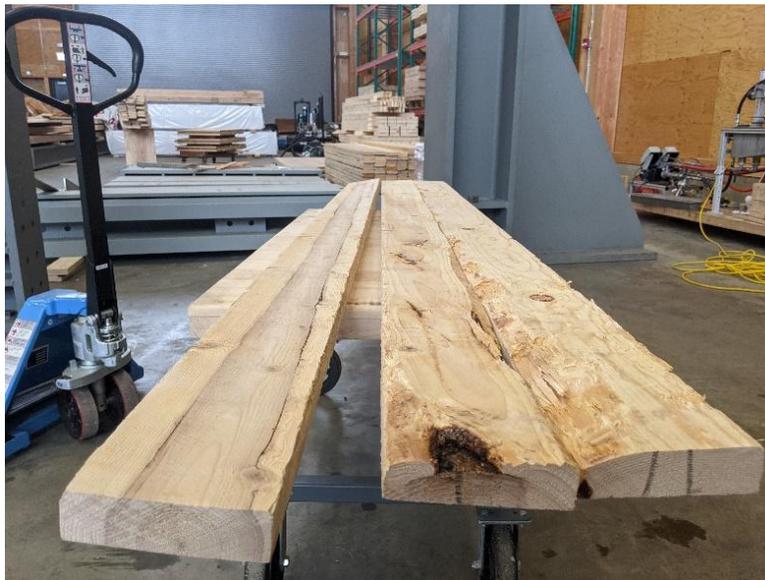
Figure 1: Examples of rejected boards

The boards pictured in Figure 1 were rejected due to extremely poor surface quality and excessive twist.

Individual boards in each unit of lumber were visually inspected for obvious deficiencies such as excessive bow and twist, and for the presence of rock chips and other foreign matter. Sub-standard boards were rejected. Hand-scanning was then carried out with a metal detector to locate staples that had been inserted during the lumber wrapping process.

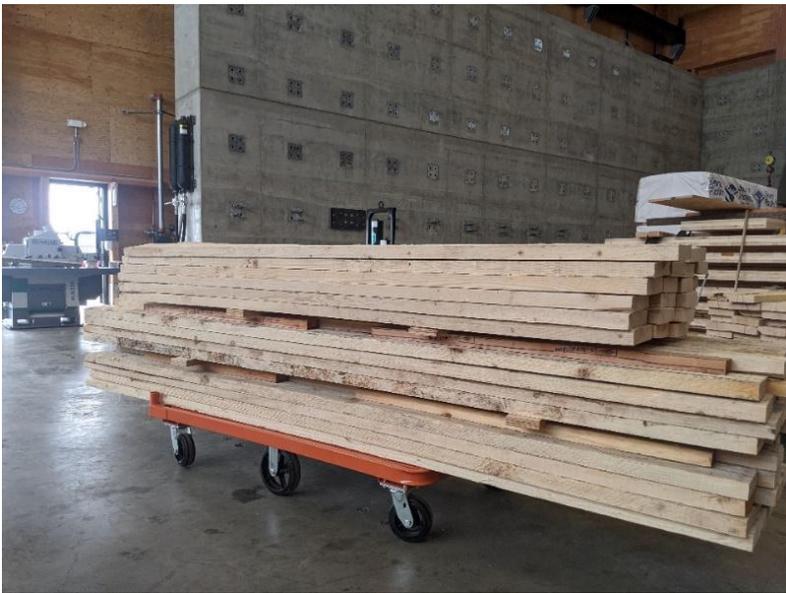
Figure 2: Boards stacked on carts, ready for planing

Once sub-standard boards had been removed, the appropriate number of boards needed for each panel were pulled and placed on carts (Figure 2). 50% of our fabricated CLT test panels consisted of #2&btr throughout the panel, and the remaining panels utilized #2&btr for the outer layers and #3&btr for the middle layer. To manufacture one 8' x 10', 3-ply CLT panel (24) 8' boards and (38) 10' boards (19 boards for each face) were needed. Based on the sorting process approximately 283 boards had to be culled due to defects, which was approximately 2 units of wood.

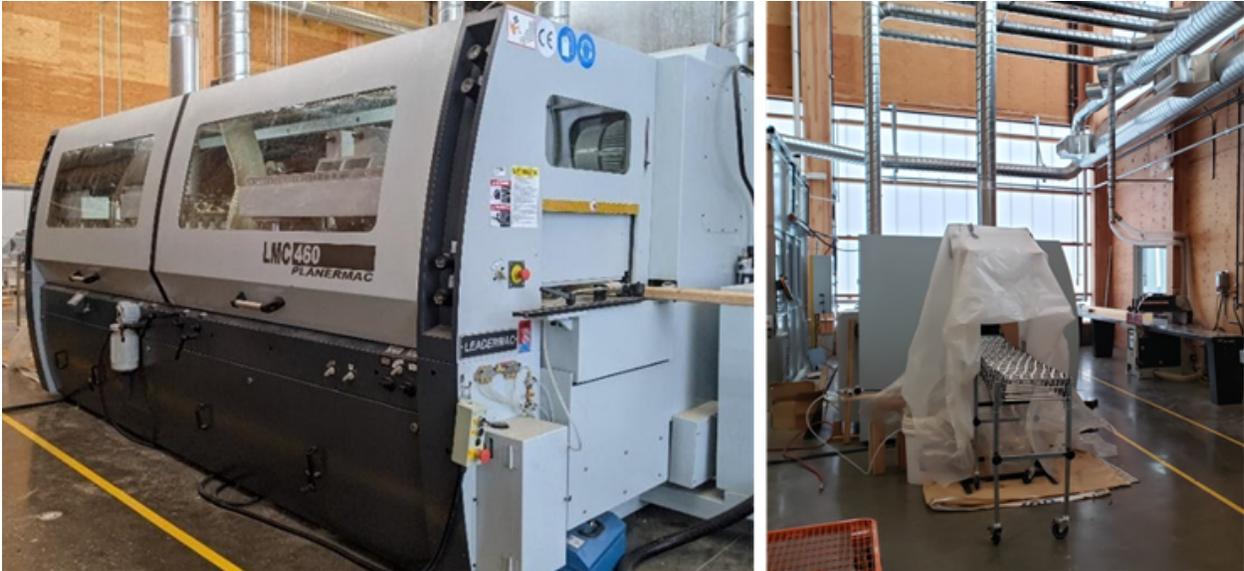
Figure 3: Leadermac Planer and primer setup connected to the outfeed of Leadermac Planer

Once all of the material was sorted, it was then taken to be planed and primed to approximately 1.375" in thickness and 5.15" width. A Leadermac LMC 460 planer was used to plane the lumber (Figure 3)

At the end of the outfeed of the planer a priming system was set up to apply the adhesive primer (Figure 3). A Henkel primer was applied at a spread rate of $2\text{g}/\text{ft}^2$, according to Henkel's instructions (Loctite PR 3105)^[1]. The boards were then allowed to dry for 1-2 hours.

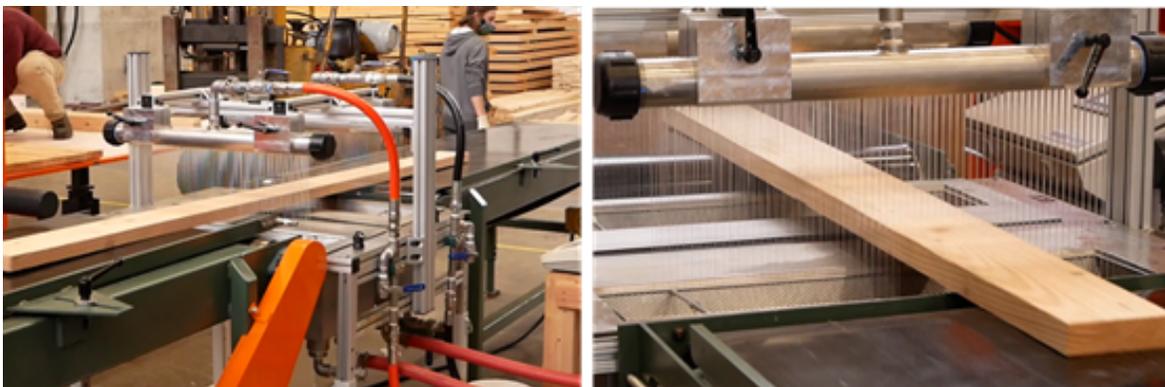
Figure 4: Resin Applicator

We fabricated the CLT panels using a Henkel polyurethane adhesive (Loctite HB X602 Purbond)^[2]. The recommended spread rate of $28\text{ lbs}/1000\text{ft}^2$ was verified by weight prior to resin application. A custom-made Apquip resin applicator was used to ensure consistent spread rate throughout the panel. The individual lumber boards (known as lamella in CLT manufacturing) were placed on a belt conveyor that passed underneath a curtain of resin.

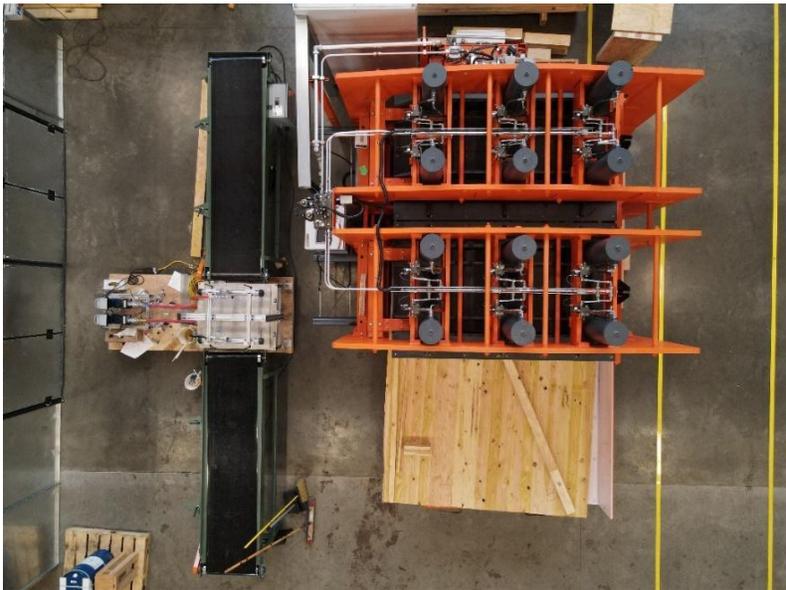
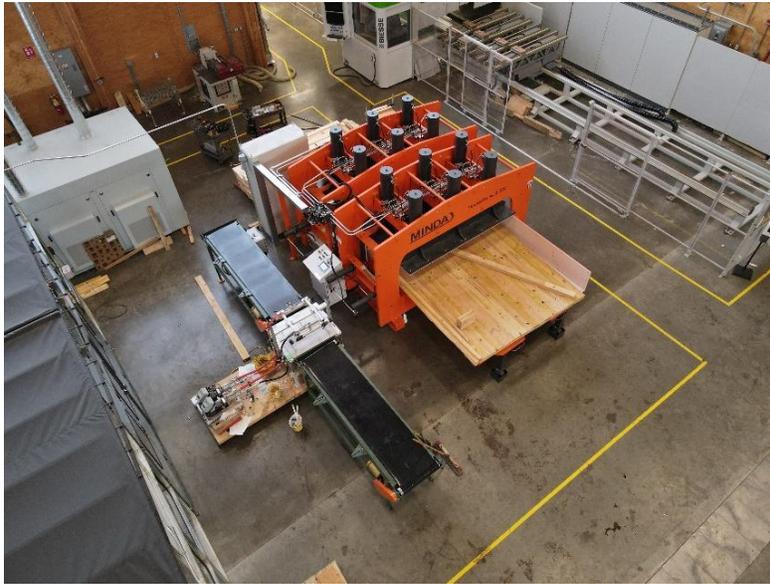
Once all the boards were placed in the press, the press was closed and set for the required pressure of the PUR adhesive, which was 120 psi (Figure 1c). The press used was a custom-made Minda CLT press which is equipped with 12 linear actuators (Figures 5 and 6). Figure 7 shows a completed panel exiting the press.

Figure 5: Apqup resin applicator (left) and Minda press (right)

Figure 6: Aequip resin applicator and Minda press

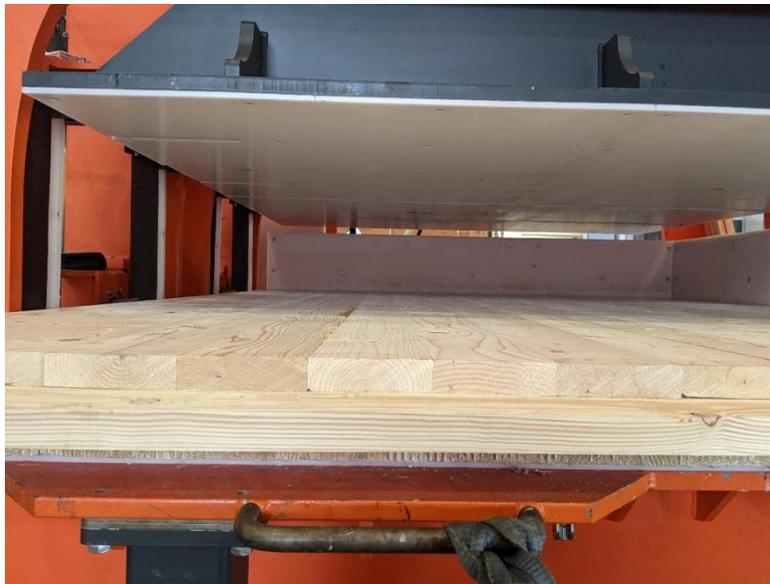
Figure 7: CLT panel immediately after pressing

The close time for the press was approximately 4 hours. The approximate time taken to complete the entire process to create one panel was around 6-7 hours.

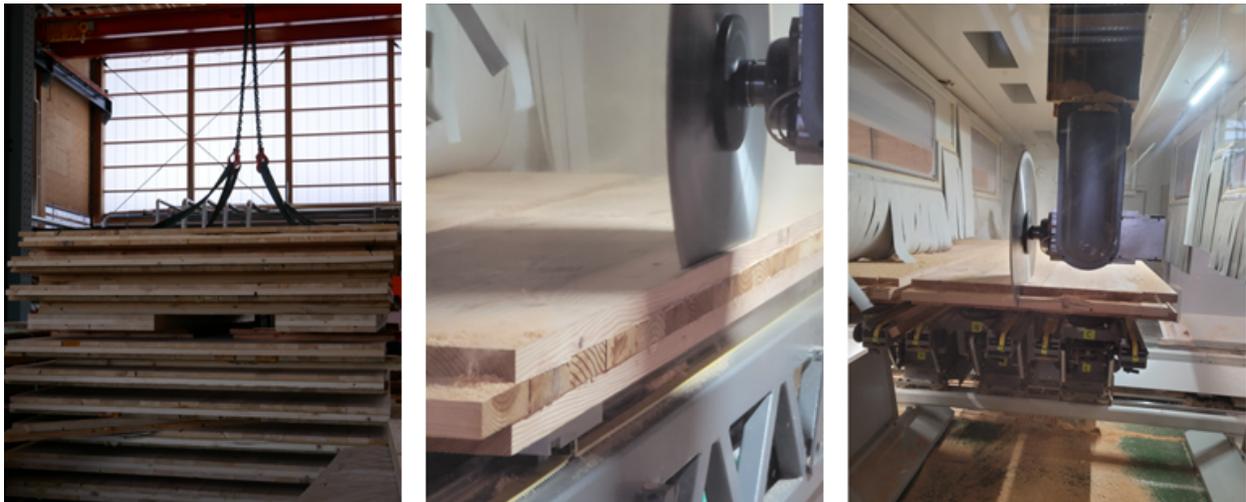
The processing of the CLT panels was performed on a Biesse Uniteam UT-9 5-axis computer numerical control (CNC) machine (Figure 8).

Figure 8 : (Left) CNC panels about to be lifted into CNC, (Center) CNC performing ripping operation on panels, and (Right) CNC performing cross-cutting of panels

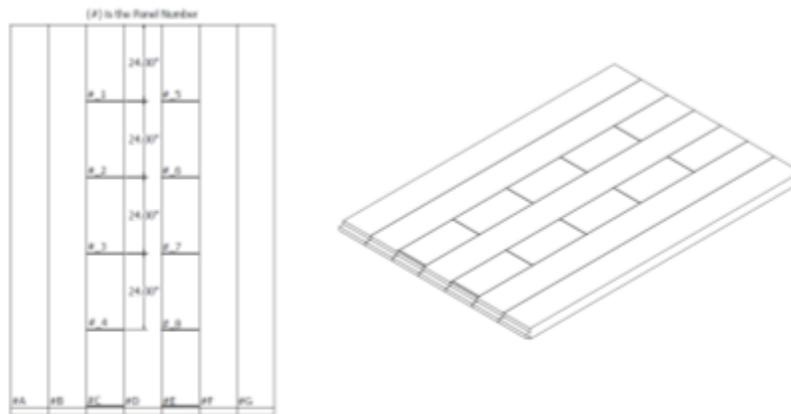
Figure 9: Panel cutting layout.

Each panel was ripped into a total of 7 (12" x 120") strips and then labeled with the panel number (1-14) and the location of the panel (A-G). Strips A, B, D, F, and G were put aside for long span testing, while strips C and E were cut down further for short span testing, shear block testing, and delamination testing. The cutting pattern can be seen in Figure 9.

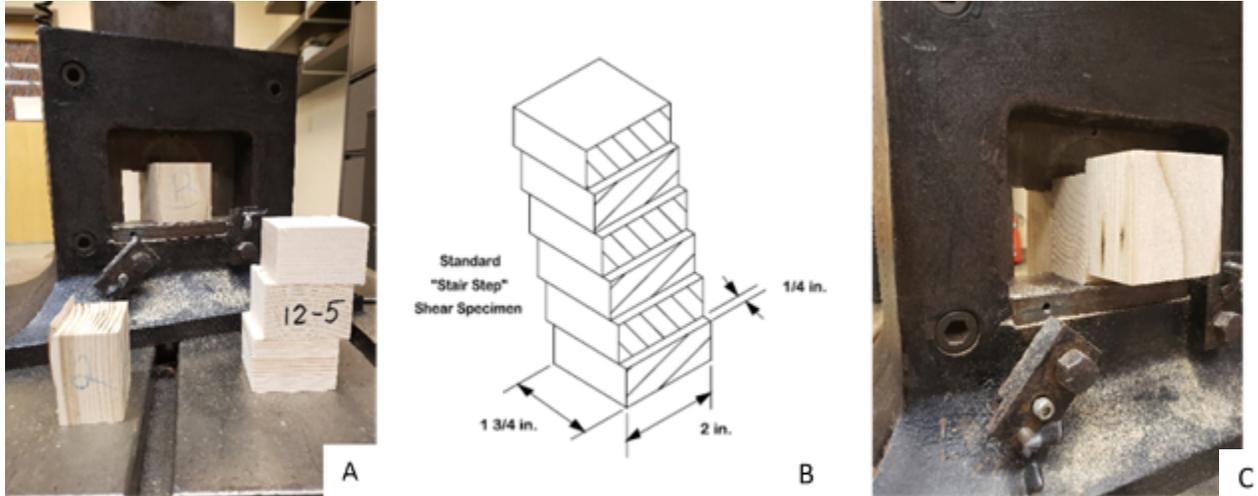
Shear Block samples were cut from the 3" x 3" blocks to then be cut into stair step samples as seen in Figure 10a and 10b. The Samples were tested following the AITC Test Method for Structural Glued Laminated Timber. The samples were placed into a shear testing apparatus (Figure 10c) and loaded at a rate of 0.025 in/min, until failure. Once the sample failed the bond area was sheared off completely to expose the bonded area. The samples were visually evaluated to determine the failure type and the percentage of wood vs. adhesive failure.

Figure 10: (A) Shear block sample next to testing apparatus, (B) Typical shear block diagram, and (C) Shear block sample in testing apparatus

The shear blocks had a total average of approximately 420 PSI with an average wood failure of 90%. The PRG 320 minimum requirements state that the percentage of samples that experience wood failure versus adhesive bond failure should be no less than 80%. In total 27 out of 146 samples failed to reach the 80% mark. Most of the failed samples contained knots that did not allow for proper adhesive penetration.

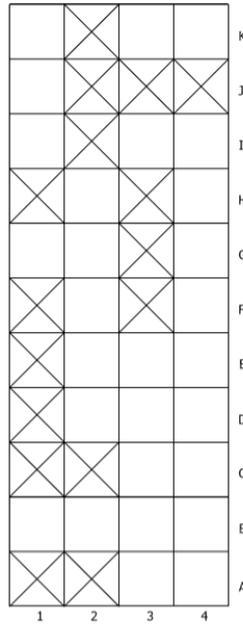
Figure 11: Delamination sample group 2 from Panel 1, strip E, Block 8

Delamination samples were cut from the 12" x 25" samples and processed into 3" x 3" cubes to be tested. The cyclic delamination test was performed following the AITC T110-2007 for cyclic delamination. There were two sample types that were tested, the first being 5 blocks from 6 random panels at different locations. The second sample type was from panel 1, strip E, and block 8. Figure 11 shows the exact locations from which the samples were taken.

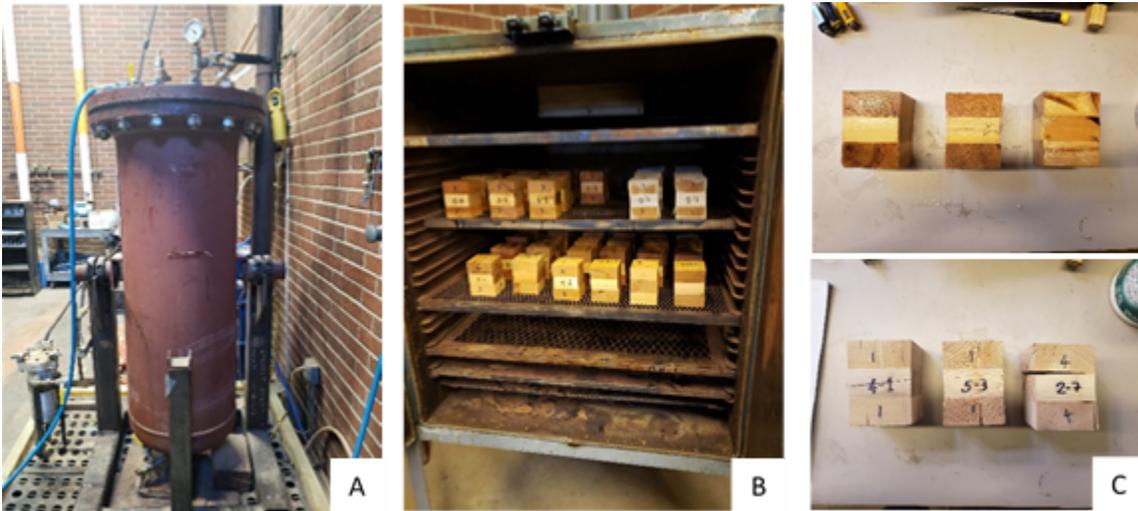
The testing utilized a single soak-dry cycle, using a pressure/vacuum vessel and an air circulating oven (Figure 12). The testing procedure began by recording the initial weights of the samples before placing them into the vessel. The samples were then submerged in water and then had a vacuum force applied for 30 minutes at approximately 12.3 psi. Once the 30-minute vacuum had elapsed the vessel was then pressurized for 2 hours at approximately 75 psi. After the pressure cycle was complete the samples were removed from the vessel and placed into an air circulating oven at 160°F. The samples would remain in the oven until they reached approximately 15% of the sample’s initial weights. The drying process took approximately 10 to 15 hours for the samples to dry down to 15% of their initial weight.

Figure 12: (a) Vacuum/Pressure Vessel, (b) Air Circulating Oven with Samples, and (c) Top: Samples after soaking, Bottom: Samples after drying

Once the samples were dry, they were analyzed for delamination. The bond line of each sample was examined for any delamination and then marked and measured. A percentage was calculated based on the measured delamination and the total length of the bond line. The averages for the panels can be seen in Table 3. In the table the samples' average delamination percentage for the top and bottom bond lines is shown. The full results for each specimen and each bond line can be seen in Appendix B.

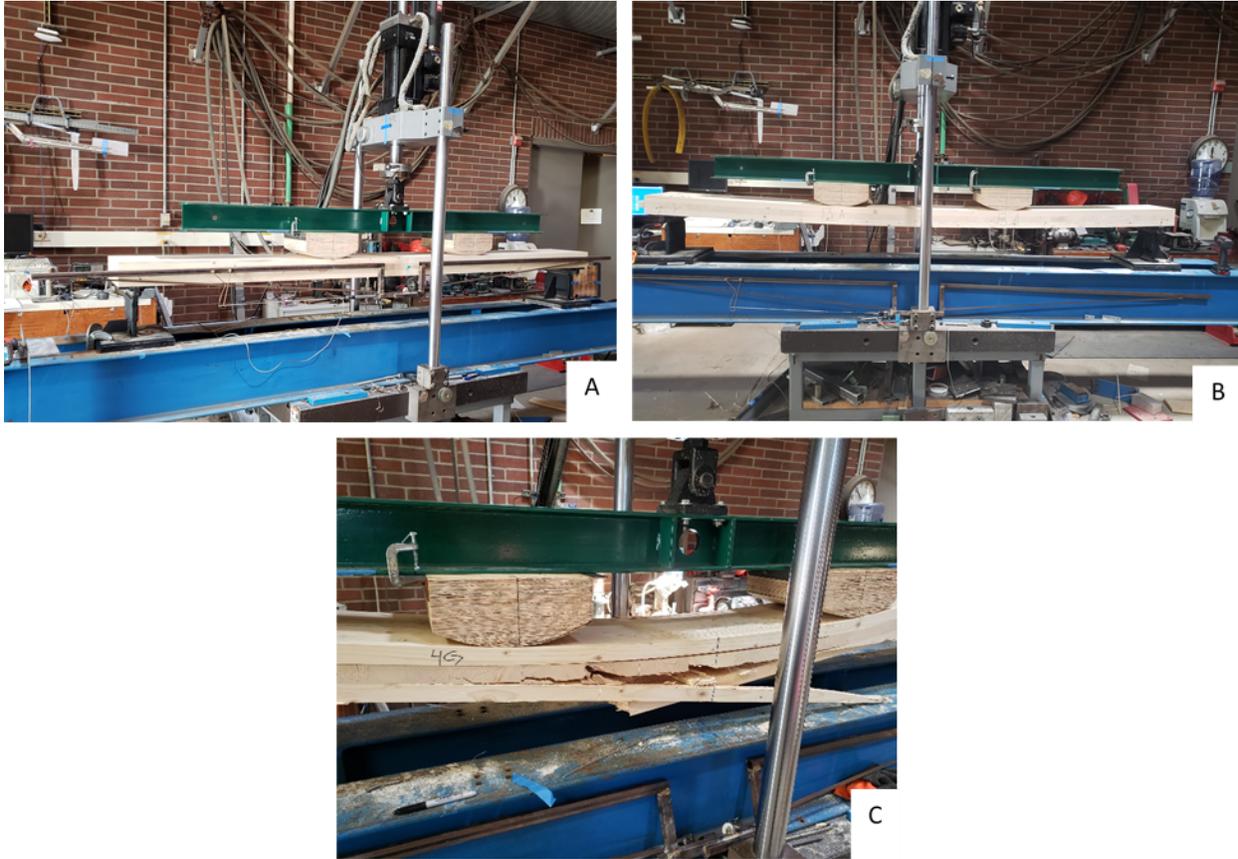
The long-span flexure test specimens used the 12" x 120" strips that were cut from each panel. The samples were tested in 3rd-point bending following the ASTM D198-15 Standard Test Methods of Static Tests of Lumber in Structural Sizes. The samples were tested as a total span of 114" with a mid-span of 38" (1/3 of the total span). The center deflection of the samples was measured with a Linear Variable Differential Transformer (LVDT) attached to a yoke that spanned the entire sample (Figure 13). The samples were tested at a rate of 0.25 in/minute until failure, and had the actuator deflection, center deflection, load, and failure type recorded.

Figure 13: (A) Test Specimen, (B) Test specimen after bridge is removed, and (C) Tension failure of Specimen.

The average MOR came to be approximately 4850 PSI, while the average MOE was approximately 1,896,843 PSI for all the CLT panels. These values were similar to the PRG 320 for an E3 panel with an MOR stated for 3-ply CLT to be 2087 PSI and an MOE of 1,640,000 PSI. When comparing the averages of the MOR and MOE of the 2&BTR and 3&BTR there seemed to be little difference. **A Statistical analysis should be conducted for further investigation.**

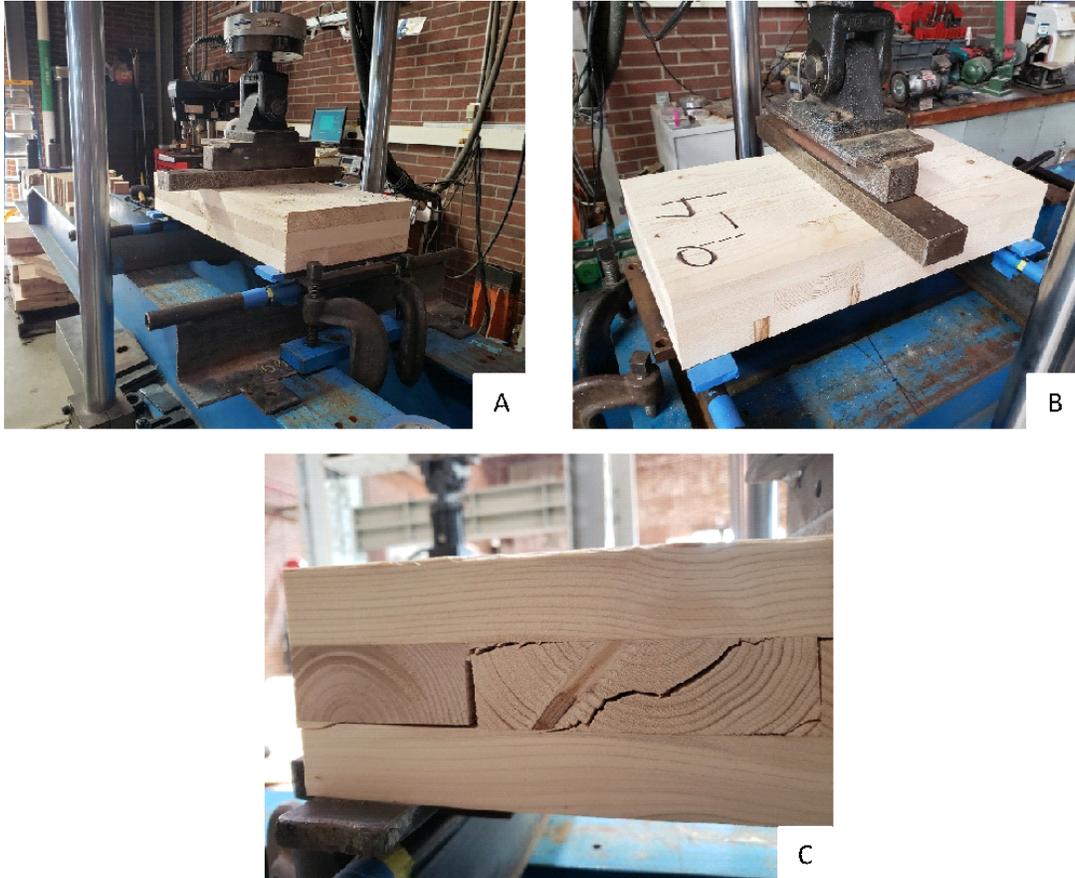
The short-span flexure test specimens used the 12" x 24" strips that were cut from each panel. The samples were tested in center point bending following the ASTM D198-15 Standard Test Methods of Static Tests of Lumber in Structural Sizes. The testing used a span to depth ratio of 5.3:1, making a span of 22". The samples were tested at a rate of 0.1 in/minute until failure, and had the actuator deflection, load, and failure type recorded.

Figure 14: (A) and (B) short span testing setup side and top view, respectively. (C) Typical sample failure, failing in shear

The overall average for the short-span shear strength was approximately 308 PSI with a coefficient of variation of approximately 14%. The samples all failed in shear near or at the bondline, with many showing rolling shear as seen in Figure 13c. Similarly to the long-span testing, the two different grades showed little difference in their average shear strength, with 2&btr at 319 PSI and 3&btr at 296 PSI.
